Objective of the Stevensville Ground Water Investigation Program (GWIP) Project

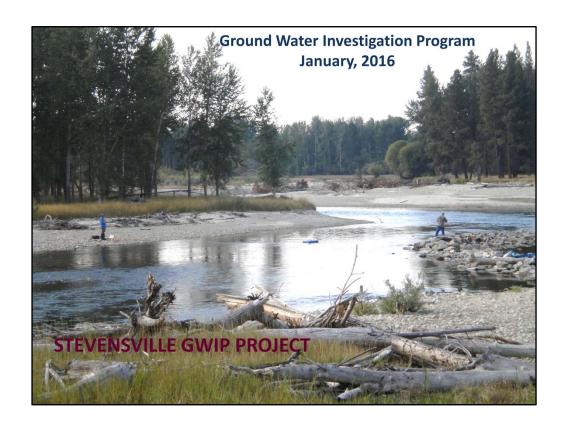
Todd Myse (left) and Kirk Waren (right) measure the flow of the Bitterroot River, west channel at Victor Crossing.

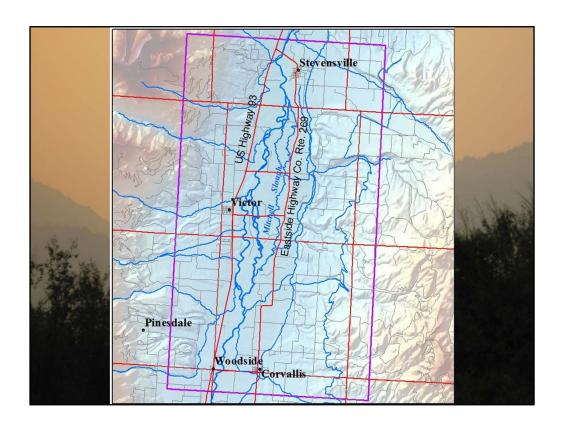
The purple rectangle shows the approximate location of the Stevensville GWIP project study area boundary.

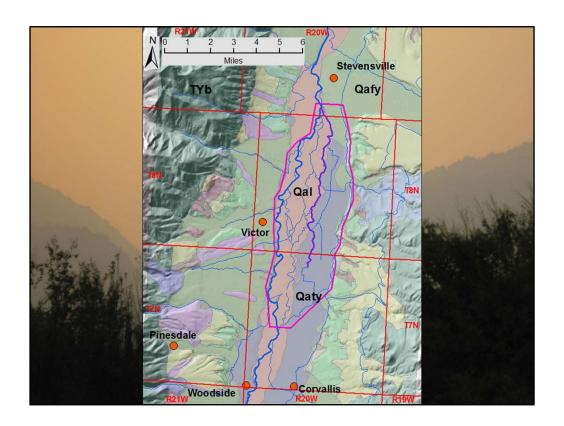
There are two main geologic units in the focus area, the Quaternary alluvium (Qal) of the Bitterroot River floodplain, and the terrace deposits (Qaty) [low terrace].

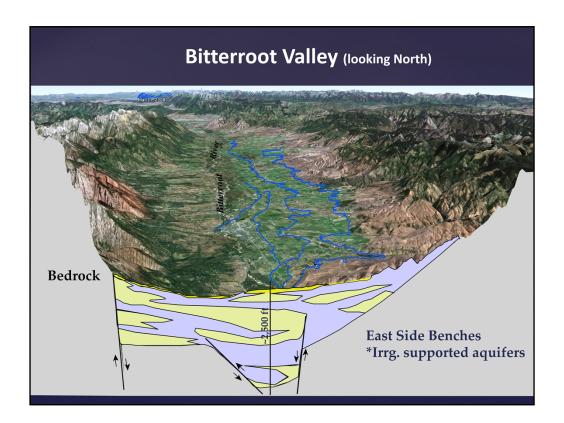
This composite view was created by Hydrogeologist Dean Snyder. It is meant to show a cutaway view of the geology of the Bitterroot Valley basin fill. The bright yellow represents relatively young stream-deposited materials of the modern and glacially-depostied alluvium beneath the floodplain and low terraces.

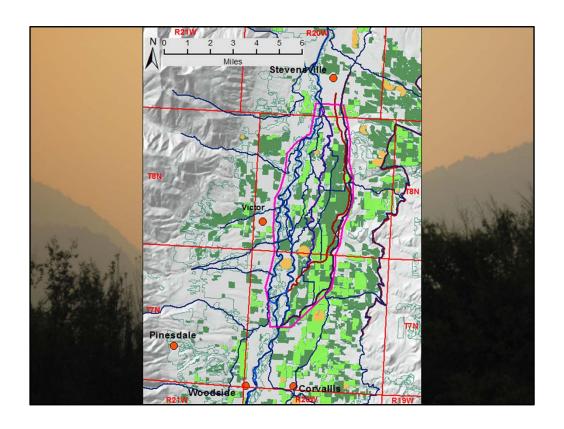
Irrigated lands as depicted in the MT Dept. of Revenues land use (FLU) coverages green: flood irrigation, light green: sprinkler/wheel line irrigation, orange: pivot irrigation.

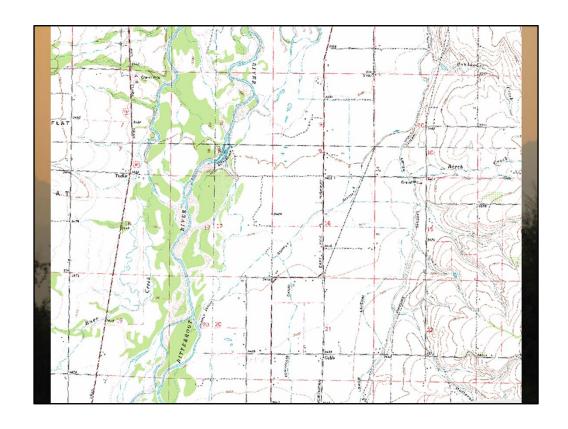
The main stem of the Bitterroot River follows the east channel on this 1967 topographic map

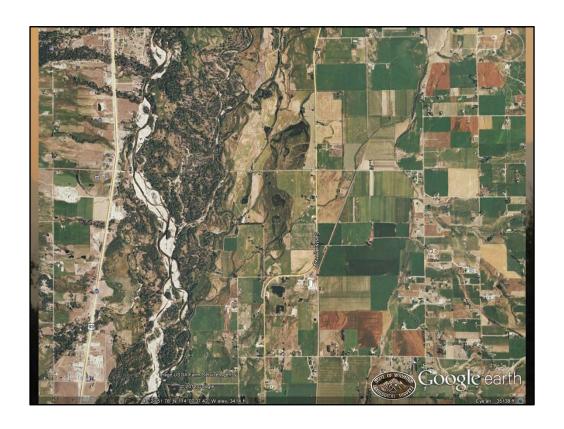
The Bitterroot River mainstem now occupies the west channel, and it takes increasing efforts to get water delivered to the Tucker Headgate on the east channel (2011 image).

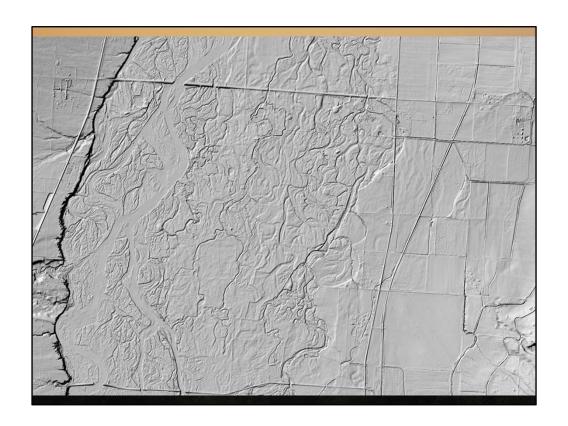
Lidar image from data provided by Ravalli County. Here the floodplain is more readily distinguished from the eastside terrace, which is flatter and has less visible channel features.

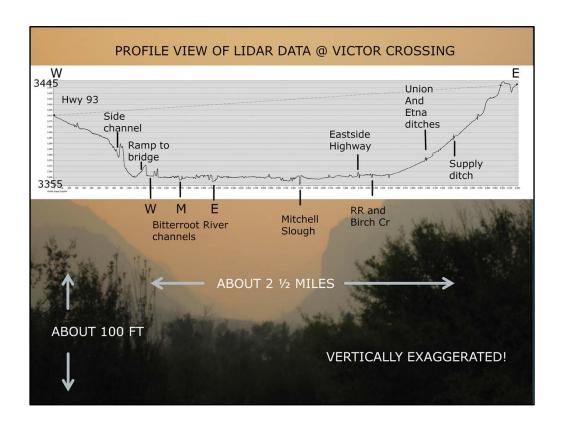
A profile view of the Bitterroot Valley at Victor Crossing. The profile is about 4 miles across, and spans 90 feet vertically, so is greatly vertically exaggerated. Note that Mitchell Slough is lower than the Bitterroot River. This image was derived during high water, the first week of June, 2008, so the elevations of the Bitterroot River channels are actually the high water at that time of year. Stages only decline a few feet in this particular area, based on data collected in 2012.

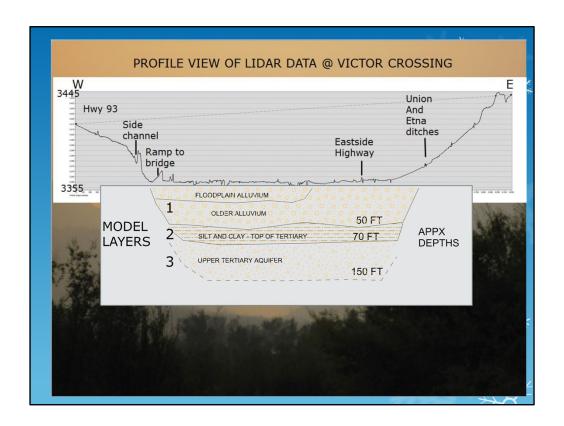
A schematic view of the uppermost 150 ft of the basin fill materials beneath the valley floor.

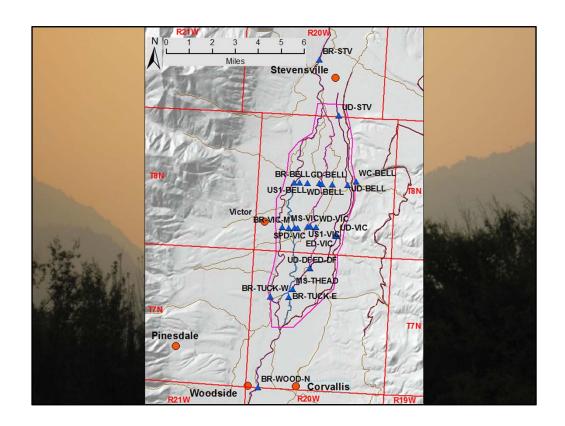
Surface water monitoring sites. Specific conductance, temperature, stage, water samples, and sometimes flow were collected at these sites, generally once a month in the winter and twice a month in the summer.

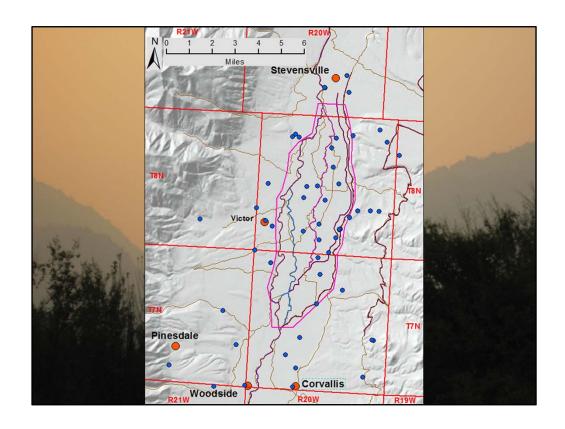
Groundwater levels were measured in over 50 wells – some of the sites shown had more than one well or piezometer.

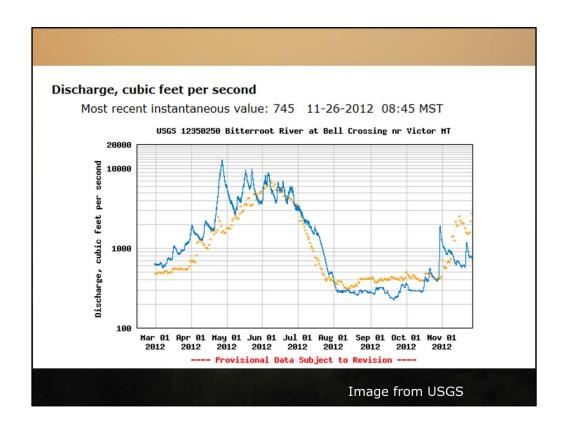
Bitterroot River discharge as depicted on the USGS website

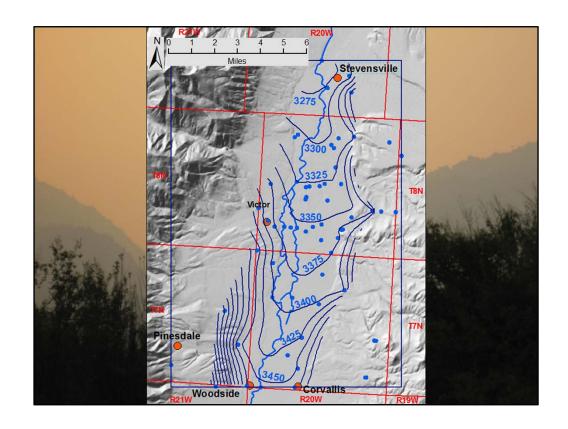
Groundwater potentiometric surface based on wells and selected surface water sites

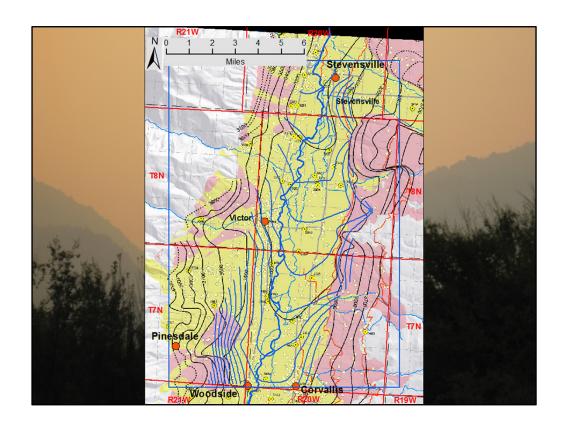
Comparing our contours to the MBMG's Groundwater Assessment Programs Ground Water Characterization Program's maps for Area #4, Part B, Map 8 (LaFave, 2006) – data from 1999 and 2000

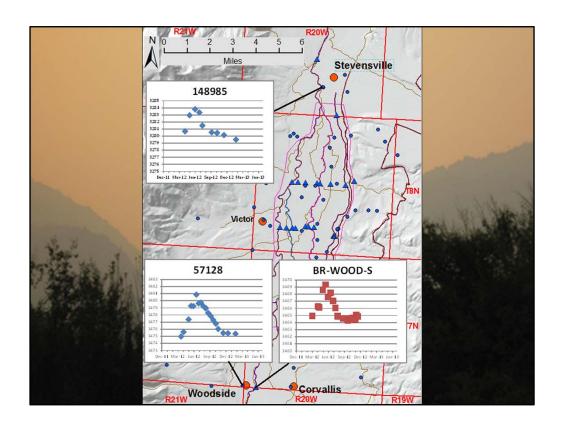
Hydrographs for wells near the Bitterroot River, compared to the stage measured in the Bitterroot River (site BR-WOOD-S). Water levels in wells near the river tend to rise and fall in patterns similar to the stage of the river.

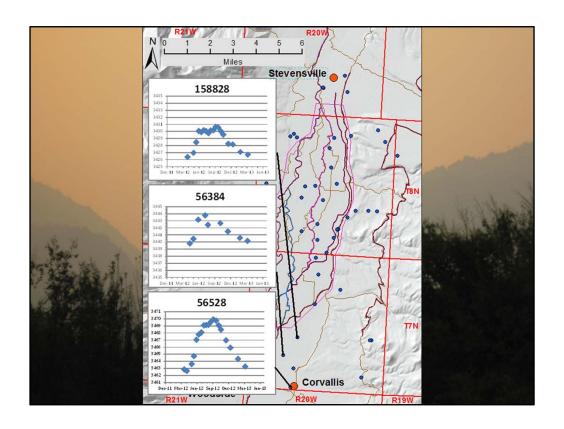
Hydrographs of wells located on the terrace respond to summer irrigation activities

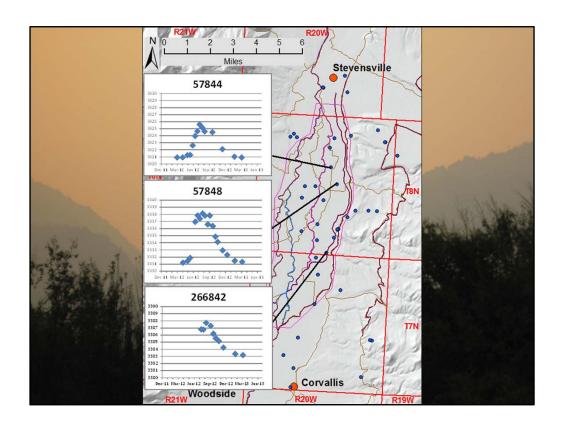
Hydrographs of wells located on the terrace respond to summer irrigation activities

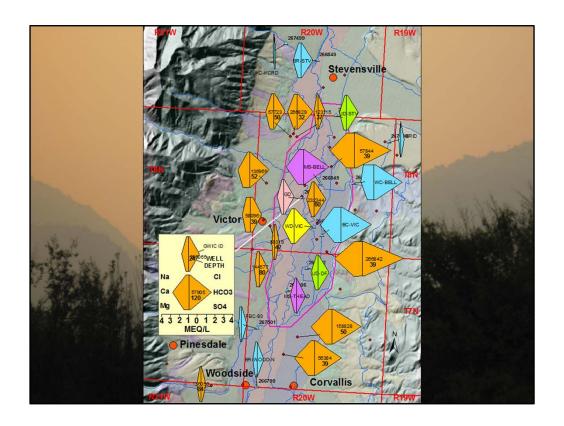
Stiff diagrams showing water quality of various surface water and groundater sites. The orange diagrams are from groundwater sites. The blue are from the Bitterroot River (BR-sites), Kootenai Creek (KC), Fred Burr Creek (FBC), Birch Creek (BC), Willoughby Creek (WC) and the Bitterroot River Irrigation District (BRID) canal. The purple are from Mitchell Slough, the pink from Gerlinger Ditch, the yellow from Webfoot Ditch, and the green from Union Ditch.

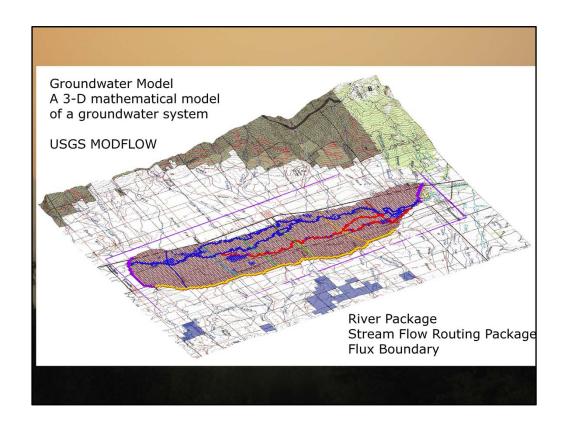
Groundwater Model grid and features

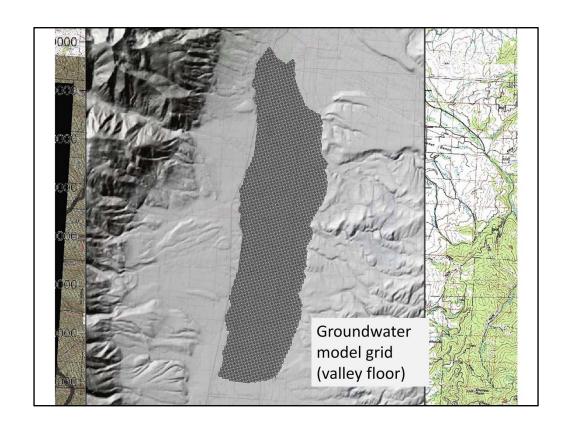
Model constructed for the valley floor area, which includes the floodplain and low terraces.

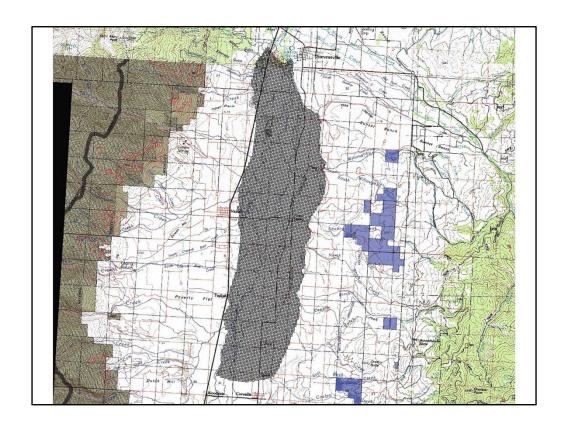
Map view of the model grid

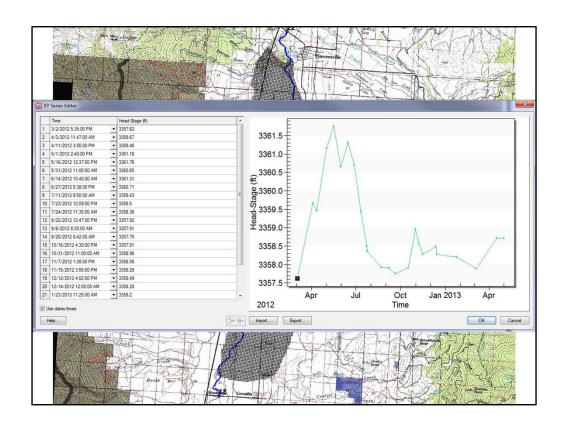
How stages are entered in the groundwater modeling program

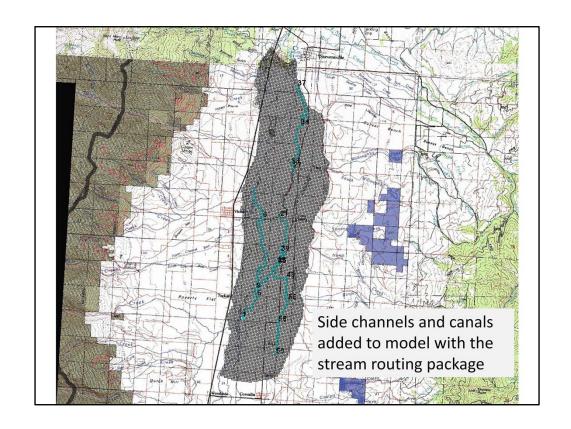
Canals and other streams added to the model using the Stream Flow Routing package

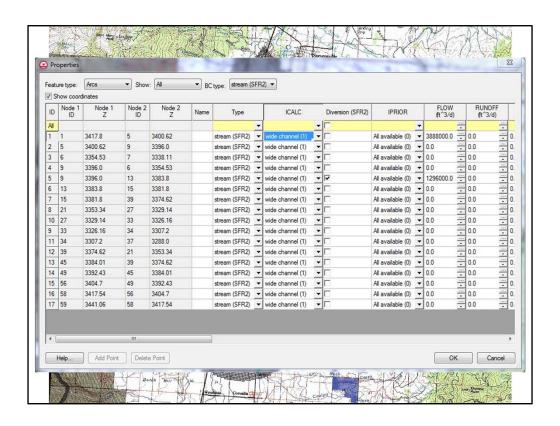
Stream Flow Routing package arcs with details partially shown

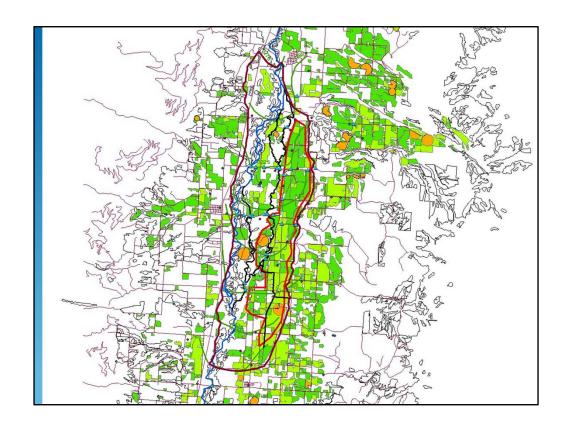
Irrigation recharge polygon (red) used to add summer recharge due to ditch leakage and excess irrigation waters applied to fields.

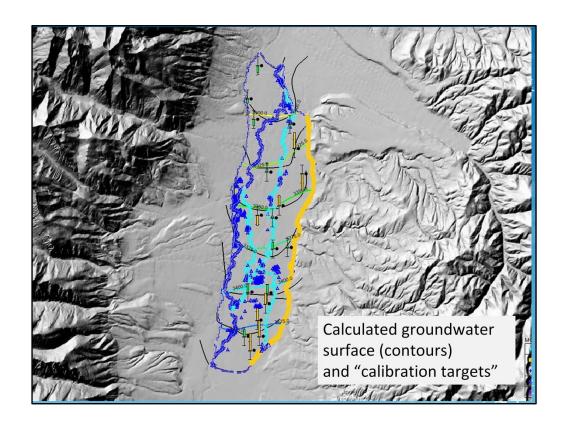
Calculated groundwater levels compared to observed values

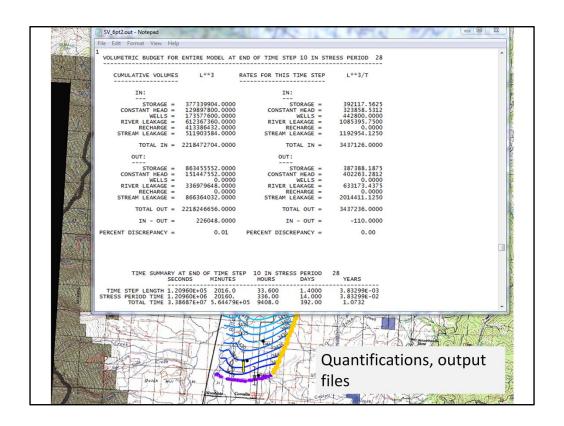
The groundwater model itself runs in Fortran programming language, and input and output files quantify the water budget.

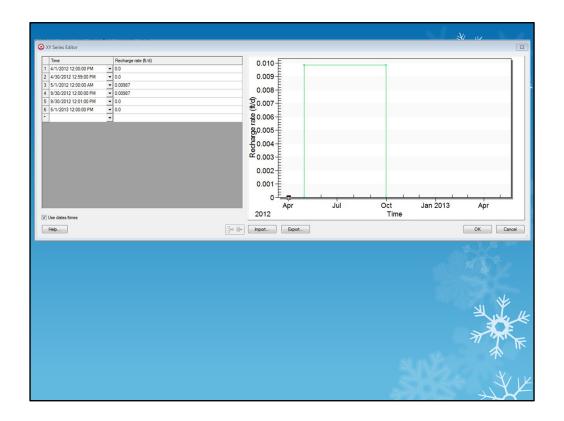
How recharge is added to the Irrigation Recharge polygon – on during irrigation months and off during the fall and winter.

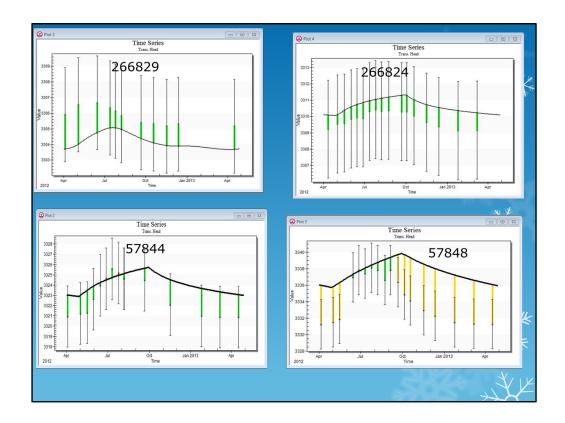
Model responses (dark black line) compared to periodic water level measurements in wells.

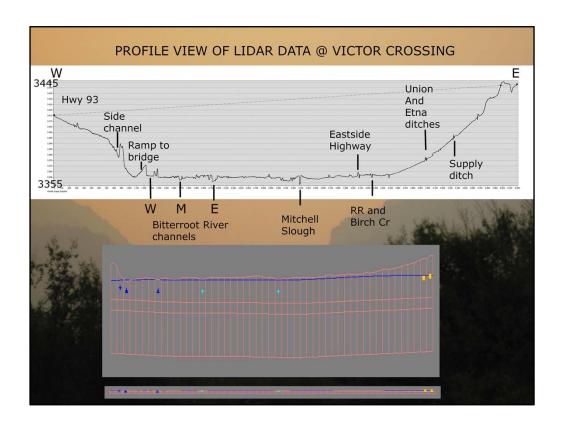
A profile view of the Bitterroot Valley at Victor Crossing. The profile is about 4 miles across, and spans 90 feet vertically, so is greatly vertically exaggerated. Note that Mitchell Slough is lower than the Bitterroot River. This image was derived during high water, the first week of June, 2008, so the elevations of the Bitterroot River channels are actually the high water at that time of year. Stages only decline a few feet in this particular area, based on data collected in 2012.

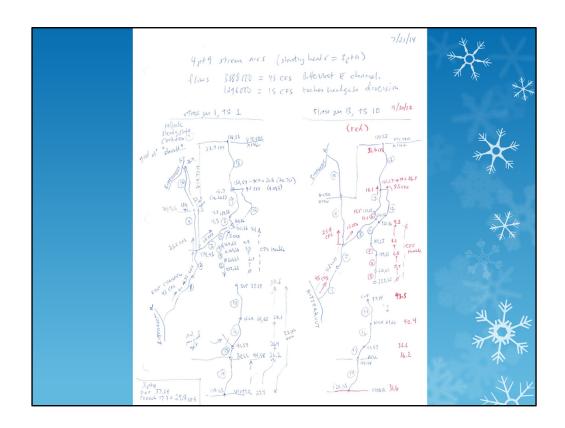
Sketches have to be made to track and interpret stream flow routing results.

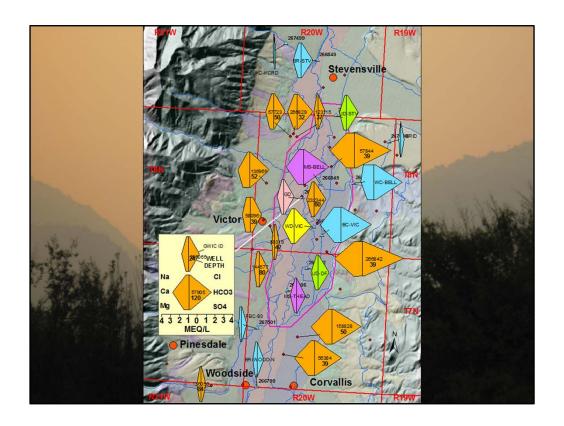
Stiff diagrams showing water quality of various surface water and groundater sites. The orange diagrams are from groundwater sites. The blue are from the Bitterroot River (BR-sites), Kootenai Creek (KC), Fred Burr Creek (FBC), Birch Creek (BC), Willoughby Creek (WC) and the Bitterroot River Irrigation District (BRID) canal. The purple are from Mitchell Slough, the pink from Gerlinger Ditch, the yellow from Webfoot Ditch, and the green from Union Ditch.
