Montana Bureau of Mines and Geology
Abandoned-Inactive Mines of the
Kootenai National Forest-Administered Land

Abandoned-Inactive Mines of the
Kootenai National Forest-Administered Land

Open-File Report
MBMG 395

December 1999

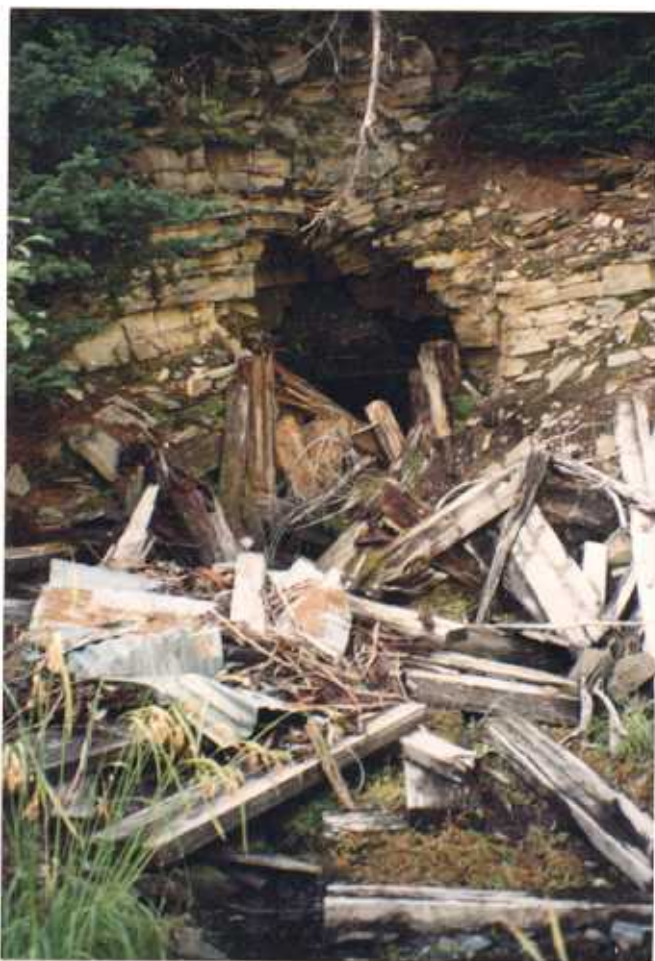
Figure 4a. The Montana Tunnel at the Jack Waite is open and had a small discharge of water that completely infiltrated into the waste dump.

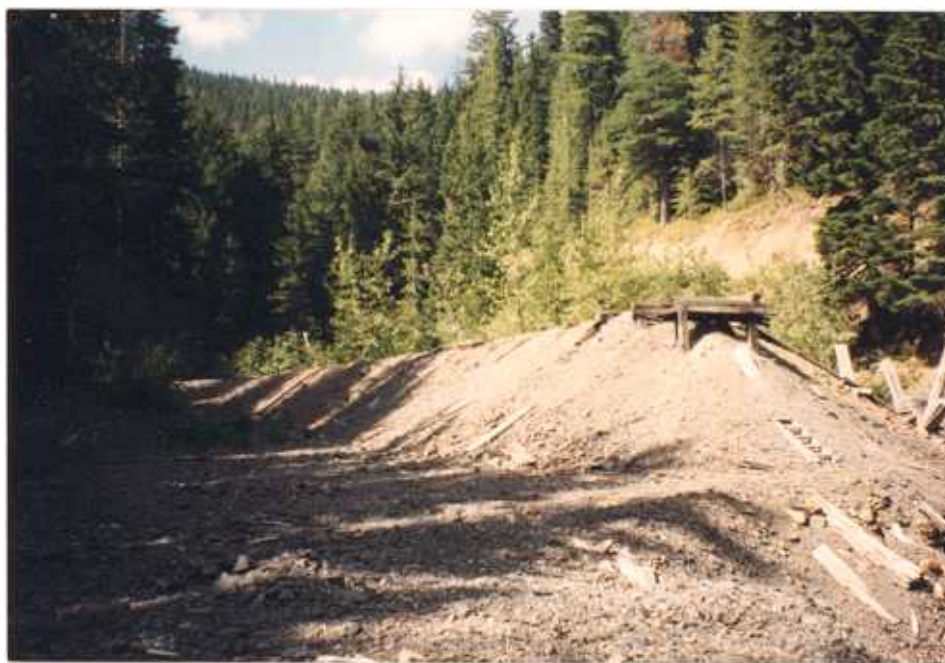
Figure 4b. Waste material partially filled Dixie Creek as photographed September 10, 1997.

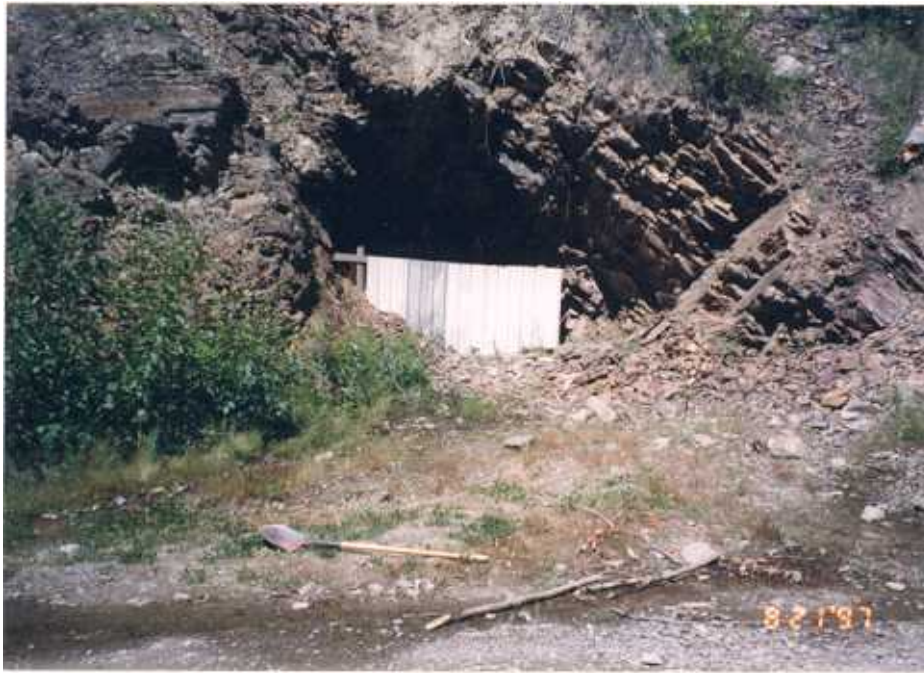
Figure 5a. The open and easily accessible Vermilion River adit was driven less than 25 feet north of the improved gravel road paralleling the Vermilion River.

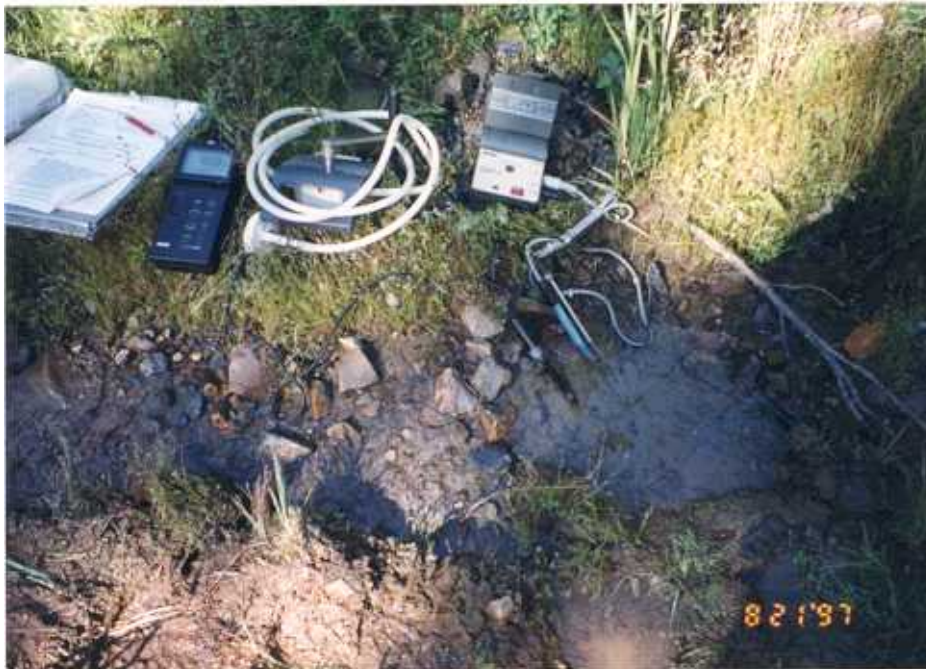
Figure 5b. Sample VVRS10M at the Vermilion River adit was taken from a small pool of water formed by the five-gpm adit discharge. It was taken on the north side of the road.

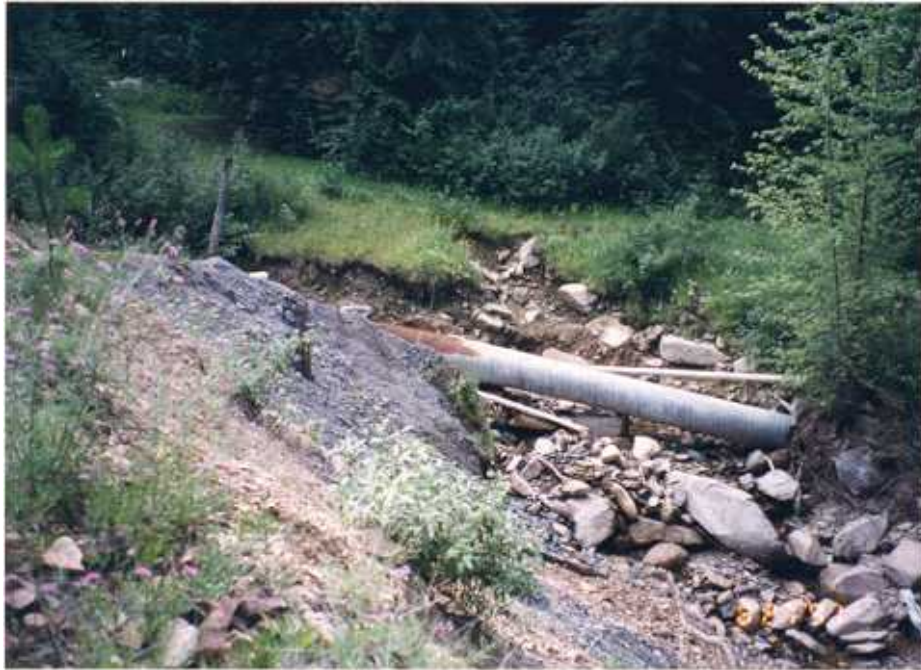
Figure 6a. Granite Creek flowed at a low rate when visited in late August but had obviously flowed at a greater rate previously.

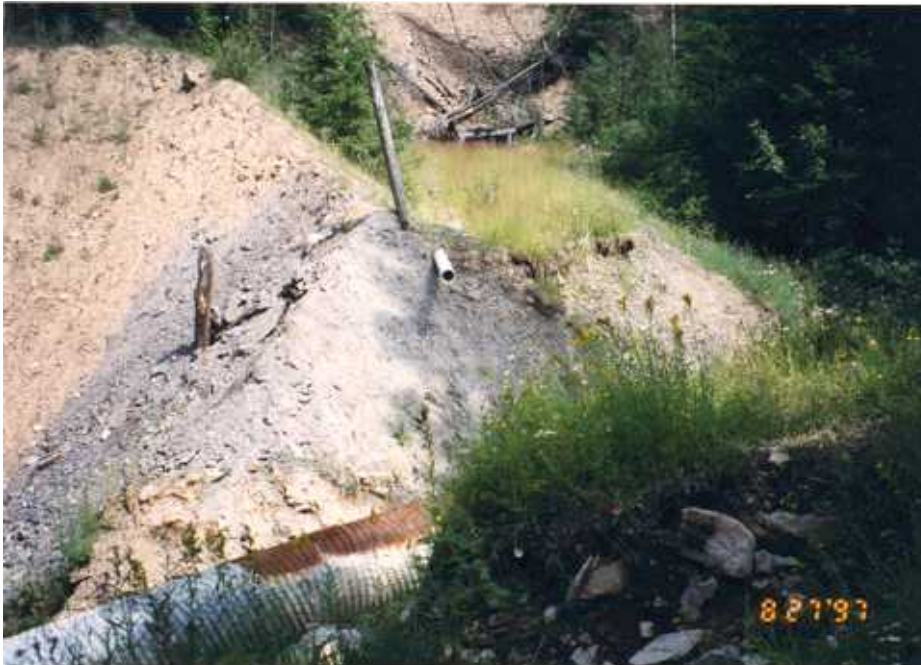
Figure 6b. Granite Creek (at low flow) has cut the waste dump at the Ambassador, resulting in an easily erodible face. The partly open adit lies in upper center of the photo.

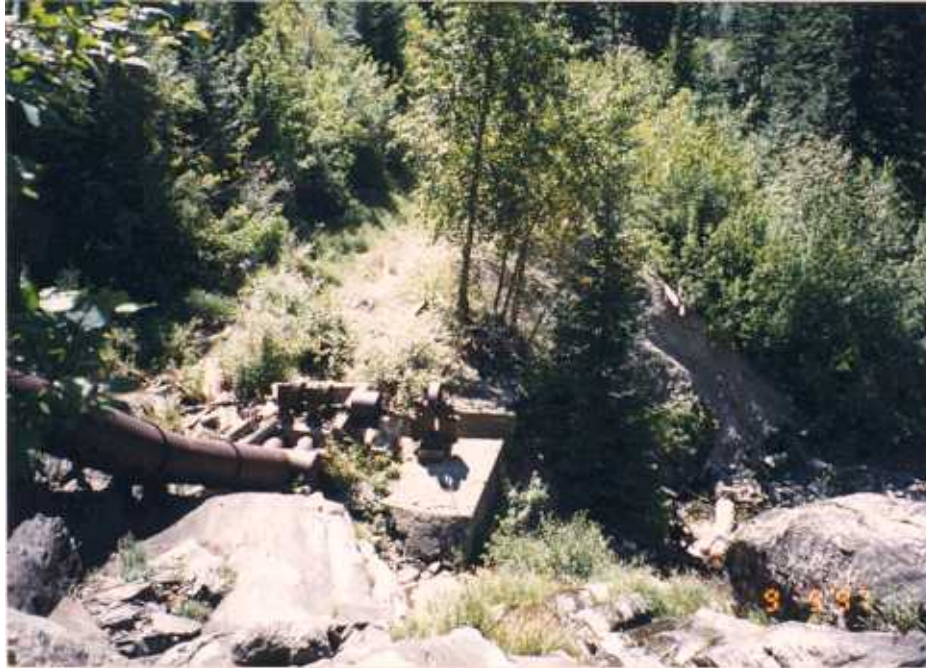
Figure 7a. As viewed from above, the Heidelberg mine consisted of a discharging adit, remnant mining equipment, and a waste dump that was in contact with Rock Creek.

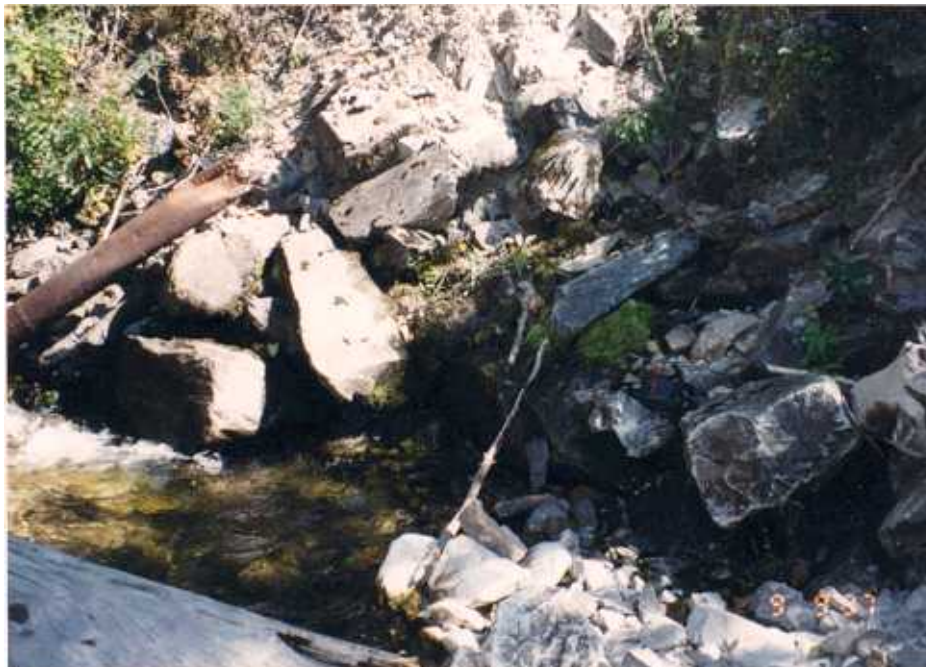
Figure 7b. The discharge from the Heidelberg infiltrated into the waste dump and discharged at the toe. The discharge emerges just below the camera case used for scale.

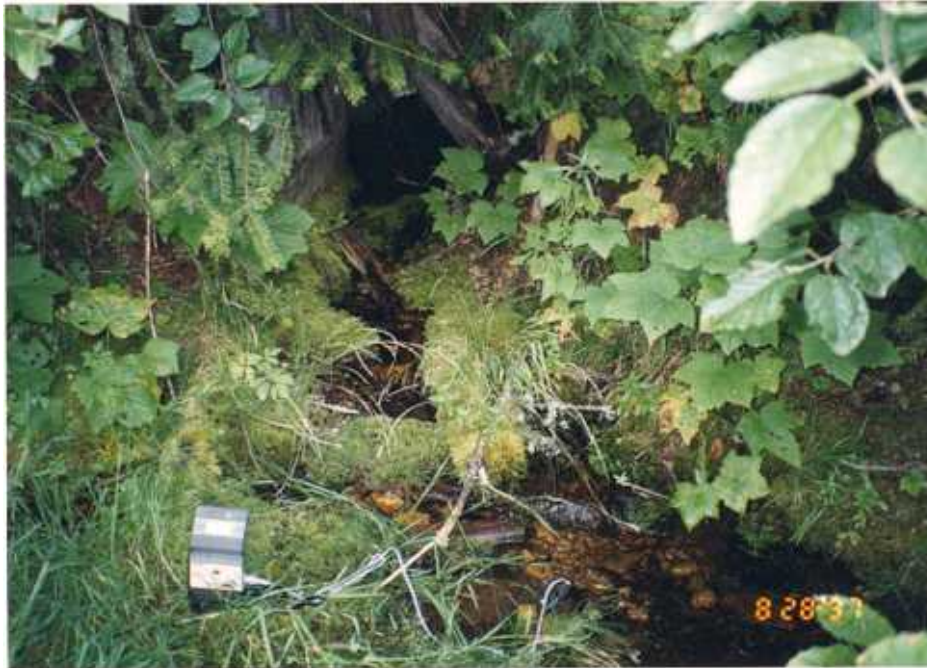
Figure 8a. At the Pilgrim mine, the 20-gpm discharge was practically hidden by the verdant undergrowth. The discharge channel had a slight iron staining.

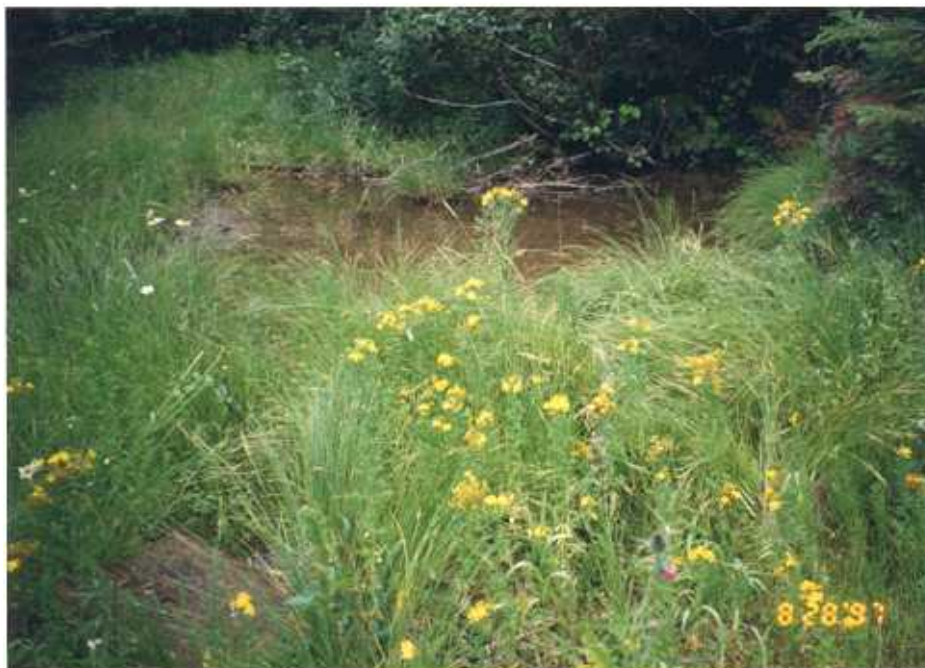
Figure 8b. A pool of water formed by the discharge at the Pilgrim mine also had healthy vegetation surrounding it.

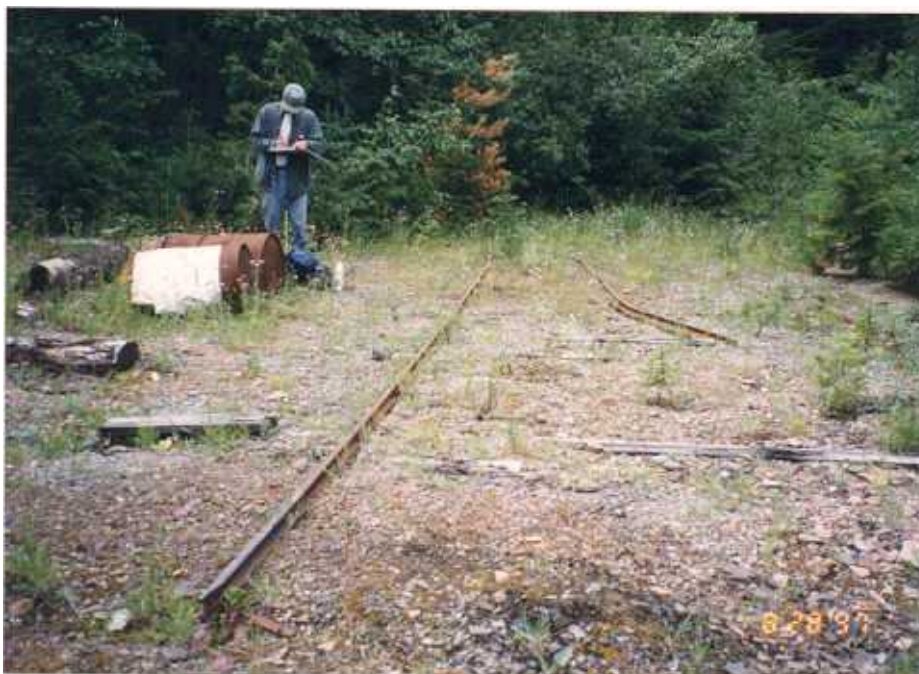
Figure 9a. At the Holliday mine, none of the structures shown in the old mine maps of the lower workings remained. Only mine car tracks and a small amount of rusting debris marked the mine site.

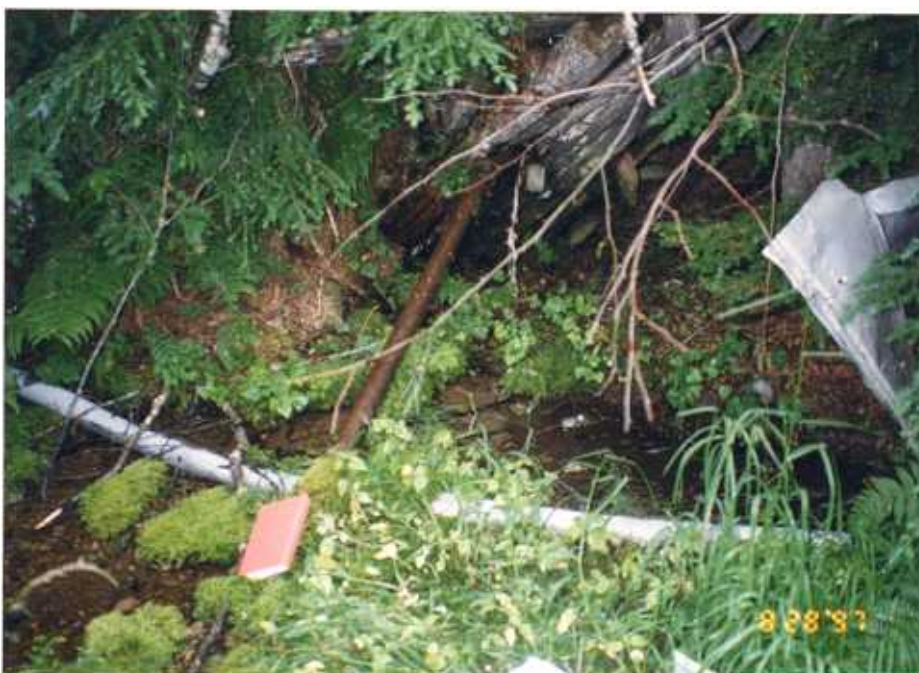
Figure 9b. The 8-gpm discharge from the lower adit at the Holliday had little evidence of metals precipitating in the channel. Hoses, pipes, and scrap metal marked the collapsed adit.

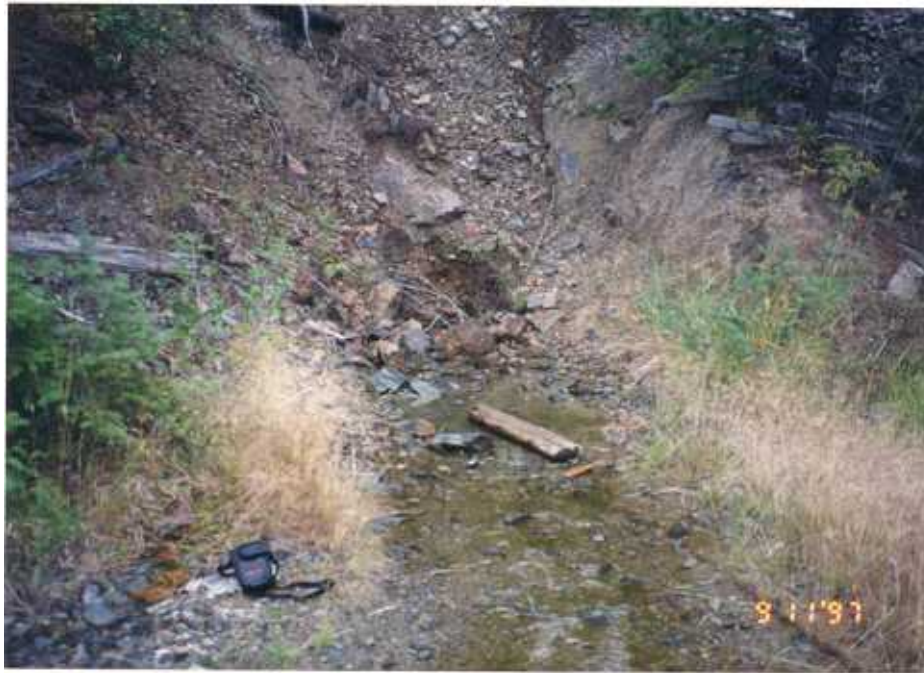
Figure 10a. Water flowed from the caved adit on patented land at the Broken Hill but immediately pooled on the waste dump on KNF-administered land.

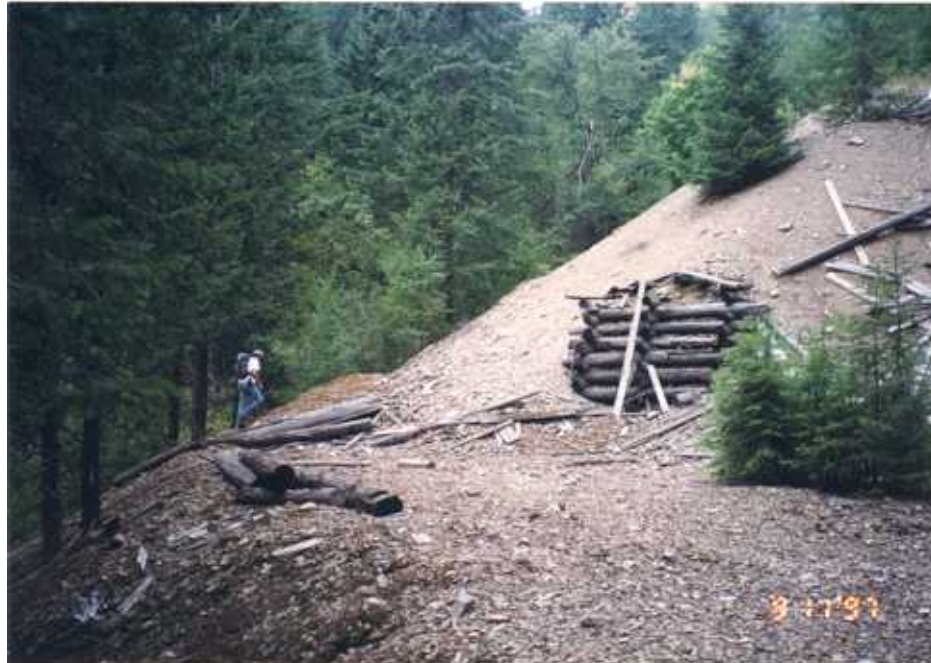
Figure 10b. The Broken Hill waste dump was steep and largely unvegetated with the slope reflecting the steep topography surrounding the site.

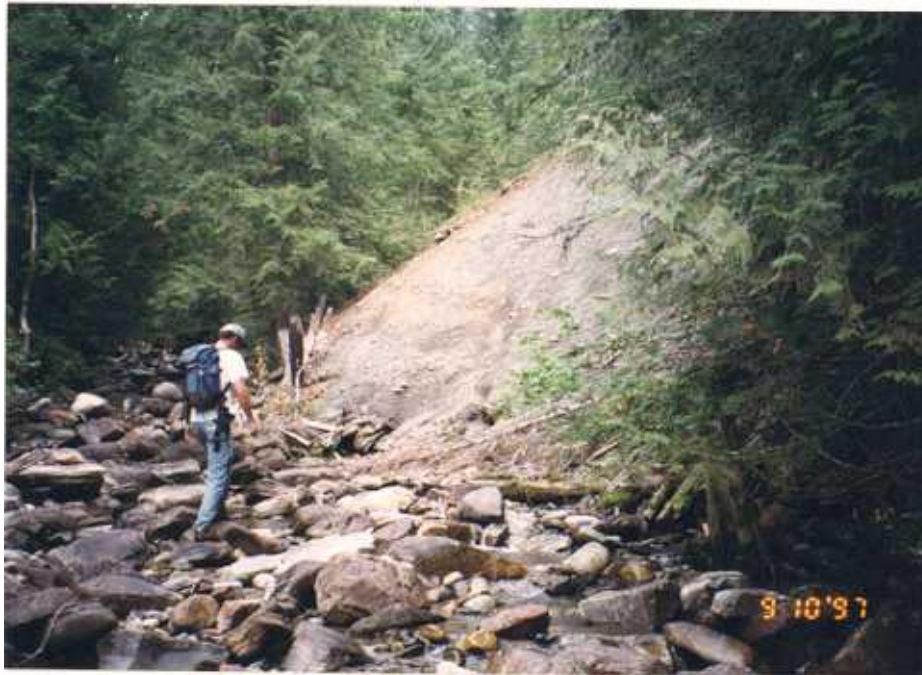
Figure 11a. The waste dump at the Blue Creek mine would be in contact with the creek during high water flow.

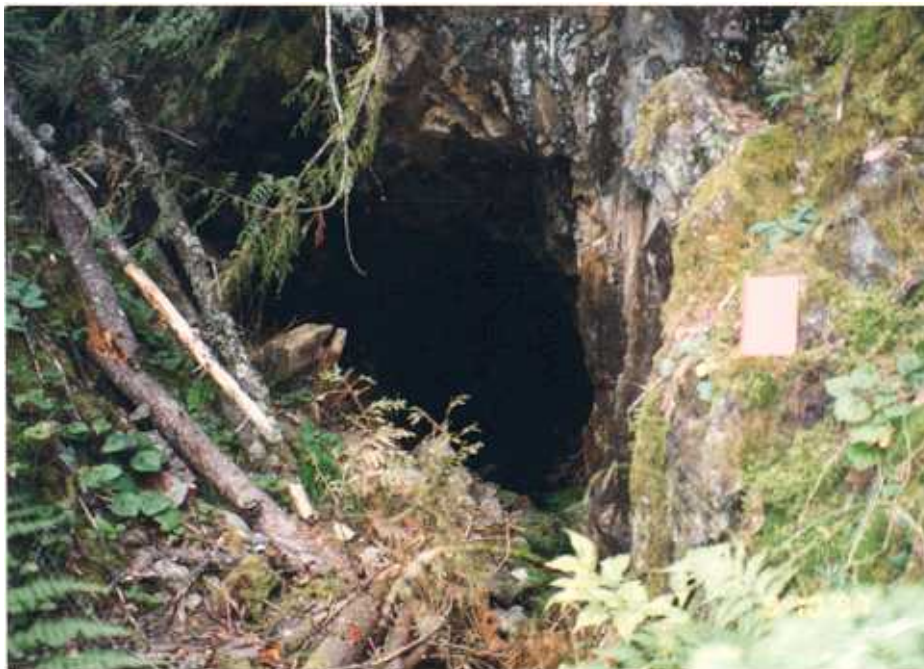
Figure 11b. The adit at the Blue Creek was open and accessible to the public, but it was on private land.

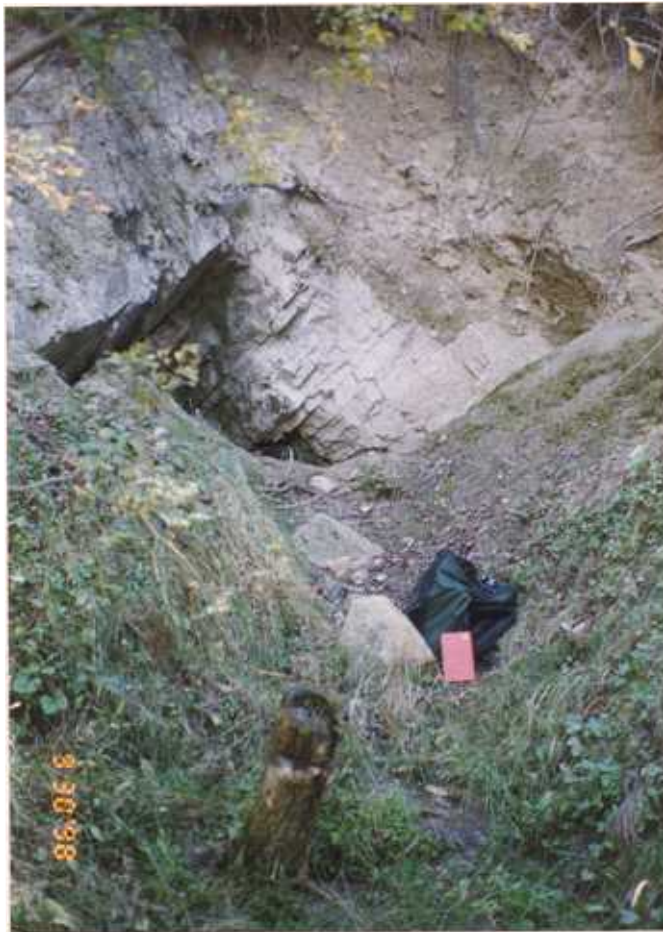
Figure 12a. The adit near Rock Lake was predominantly caved with a small rate discharge flowing from the caved portal.

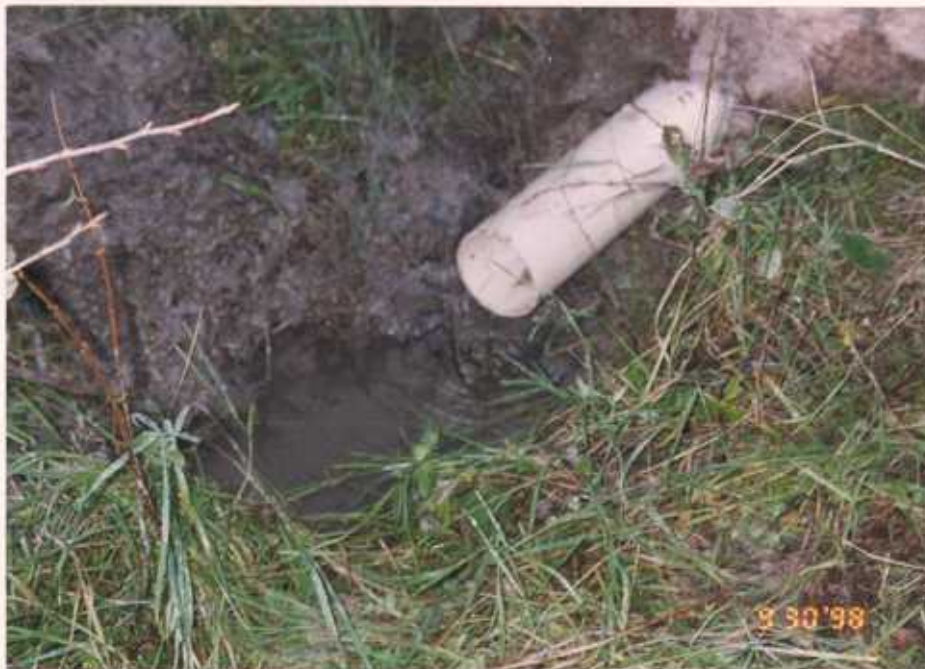
Figure 12b. The small rate flow at Rock Lake was measured as it flowed from the adit and was captured by a short piece of PVC pipe.

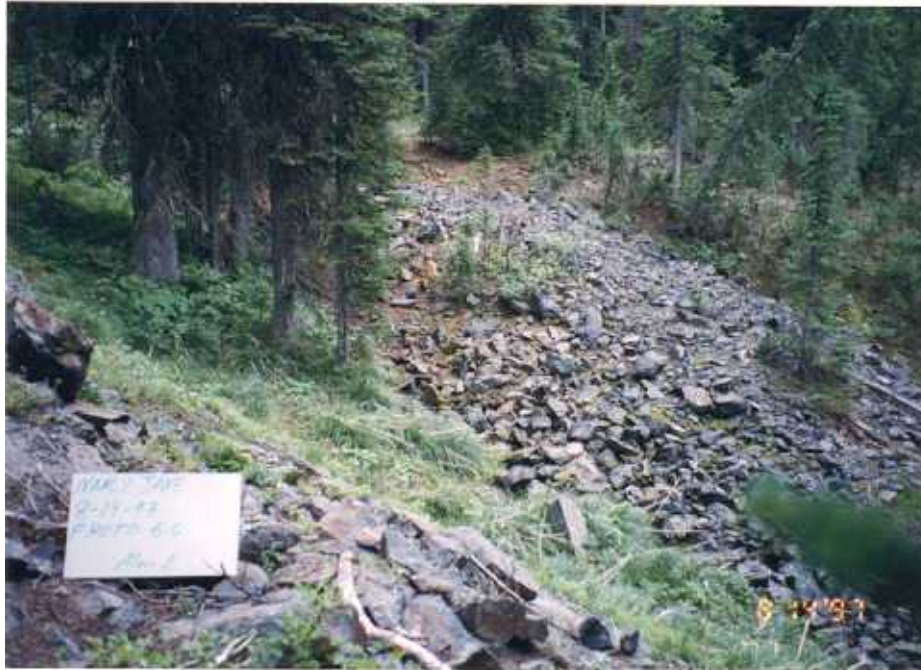
Figure 14a. The Nancy Jane mine had a small seep to the right of the photo.

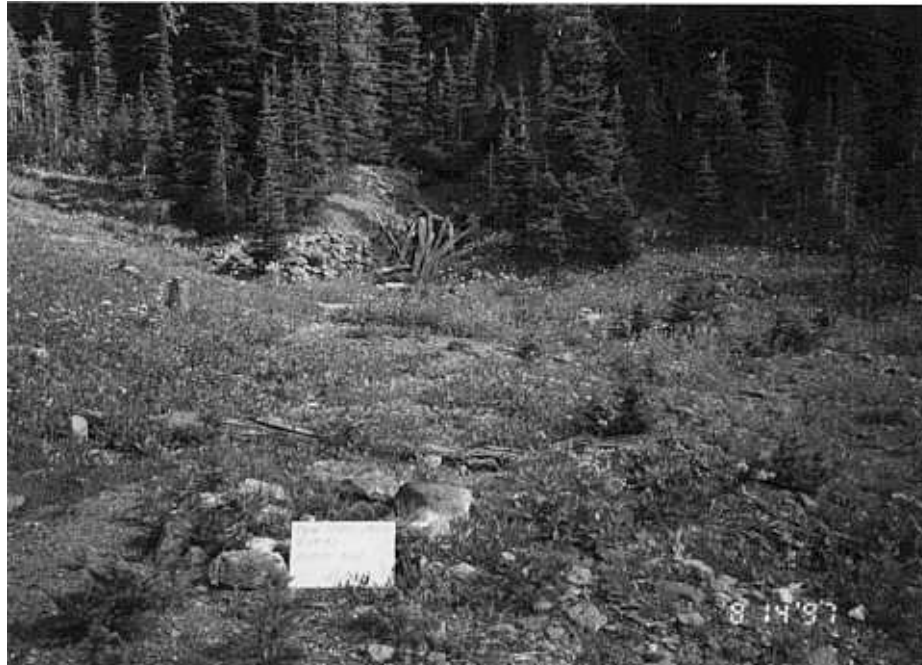
Figure 14b. The Twin Peaks mine showed no adverse effects and was largely naturally reclaimed.

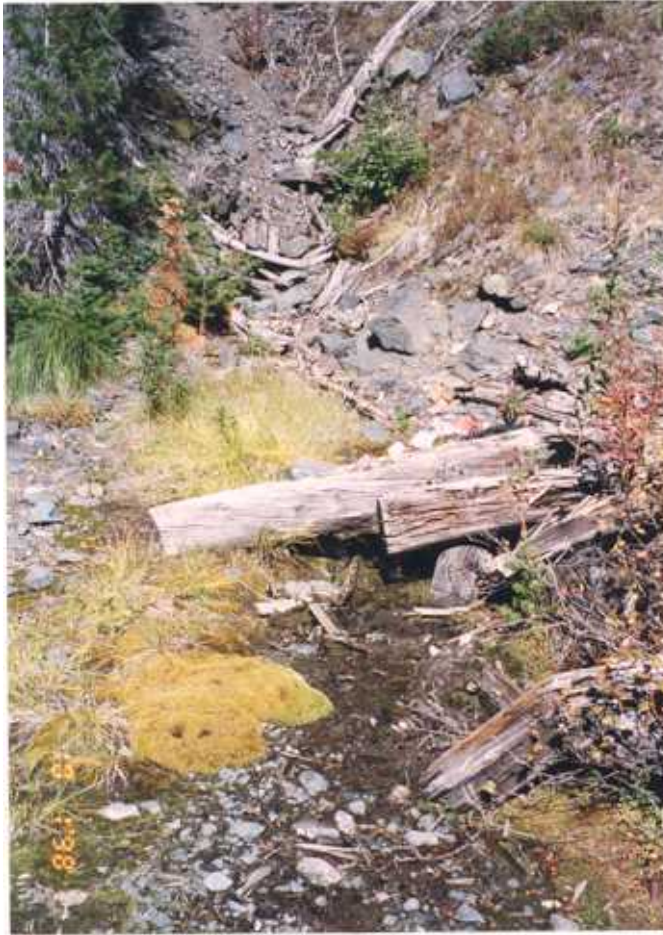
Figure 15a. Looking north at the adit discharge at the Independence, the discharge seeps from the adit and infiltrates into the waste dump. It does not re-emerge at the surface.

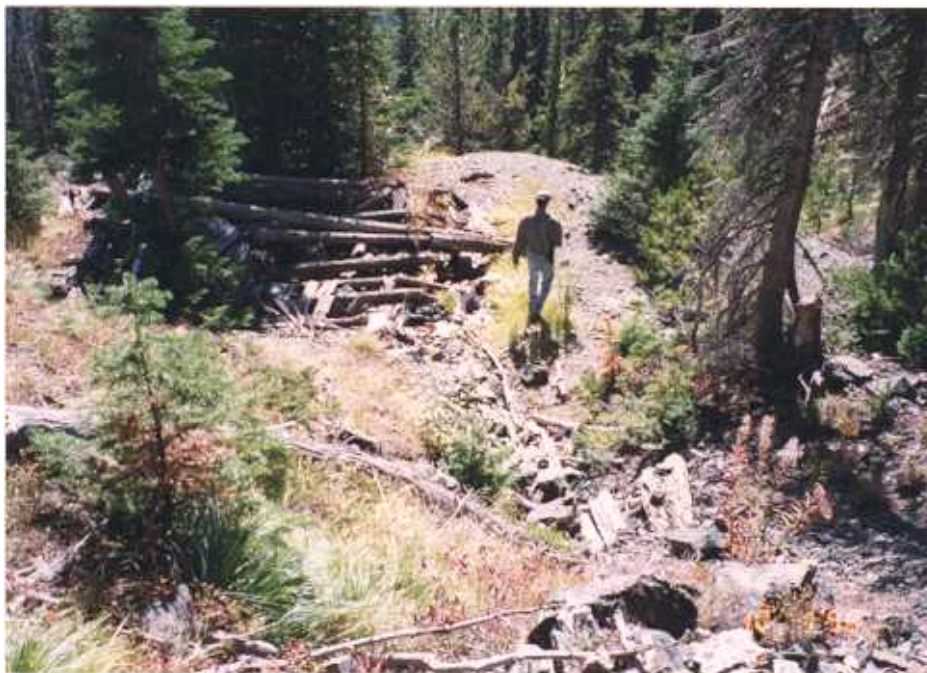
Figure 15b. Looking down from the talus and upper caved adit at the Independence, the adit can be distinguished by the green grass in front of the geologist.

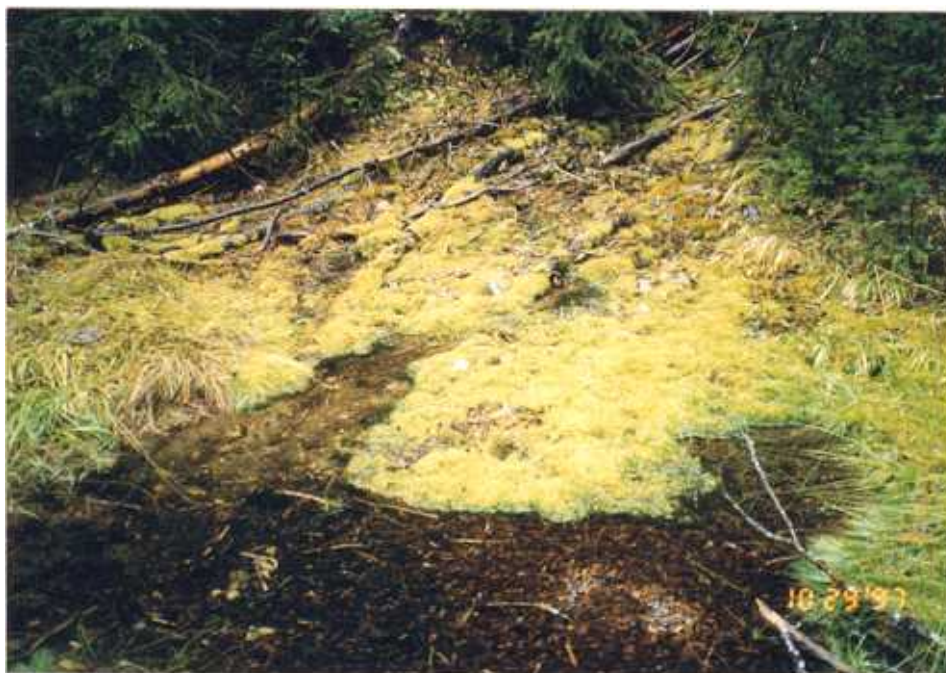
Figure 16a. The adit discharge at the Snowfall prospect pooled at the collapsed portal of the adit and formed a wet mossy area.

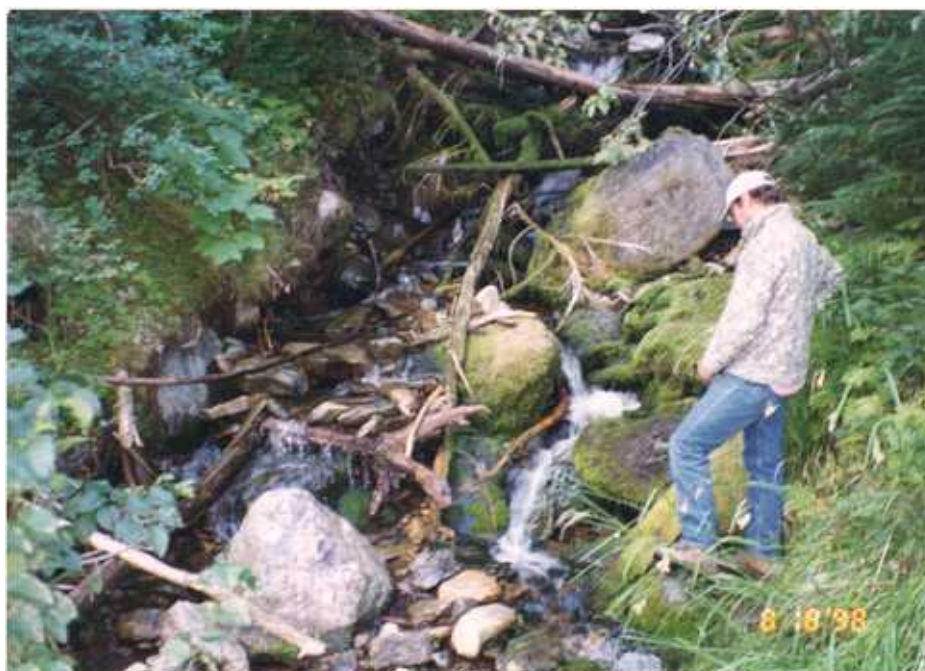
Figure 16b. A site on the South Fork of Silver Butte Creek was chosen to test the effects of mining upstream at the King mine.

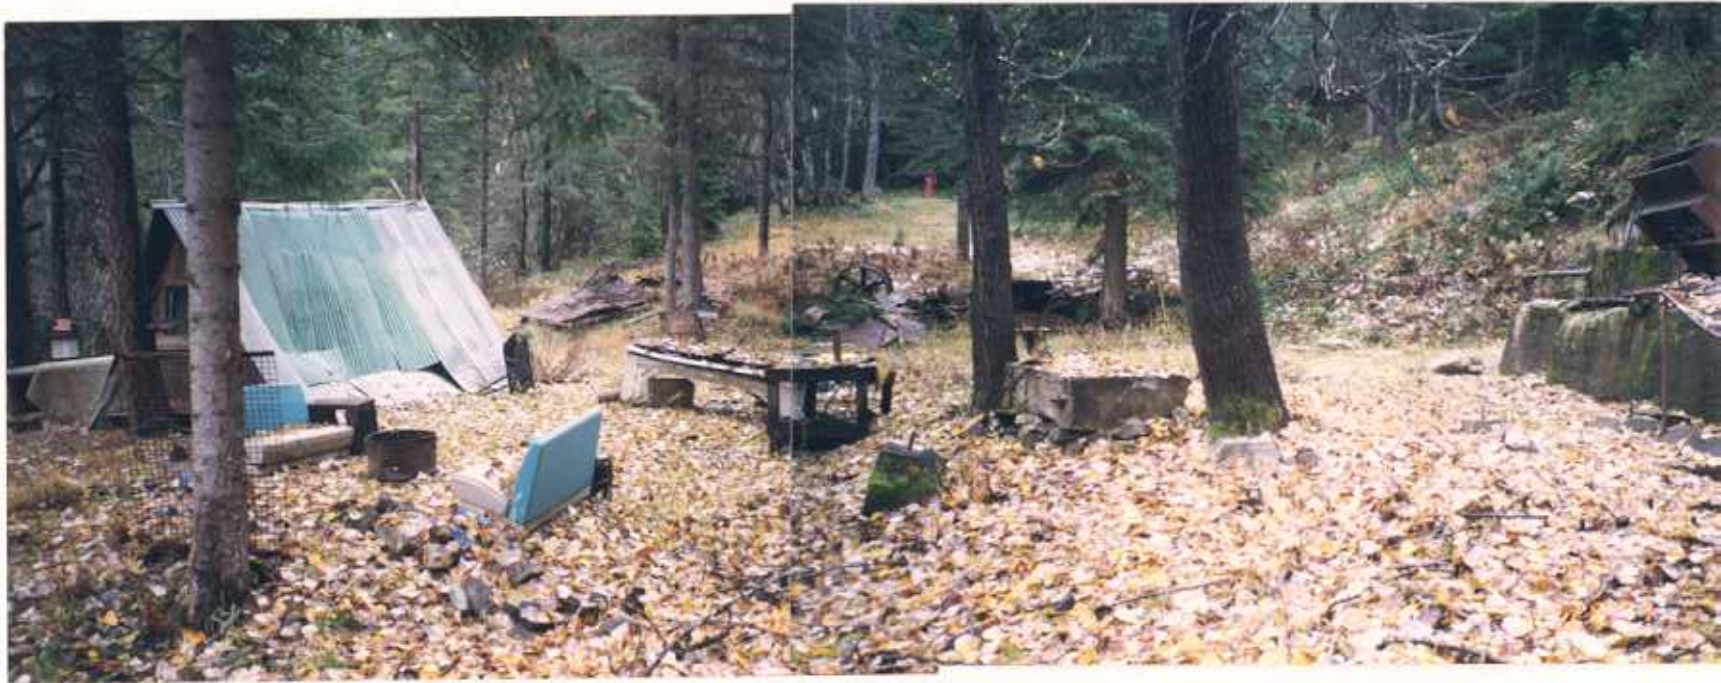
Figure 17a. Recent habitation at the Viking has resulted in a modern A-frame and the older mill foundation (right) has the remains of an old stamp mill. The USFS was planning to clean up the site.

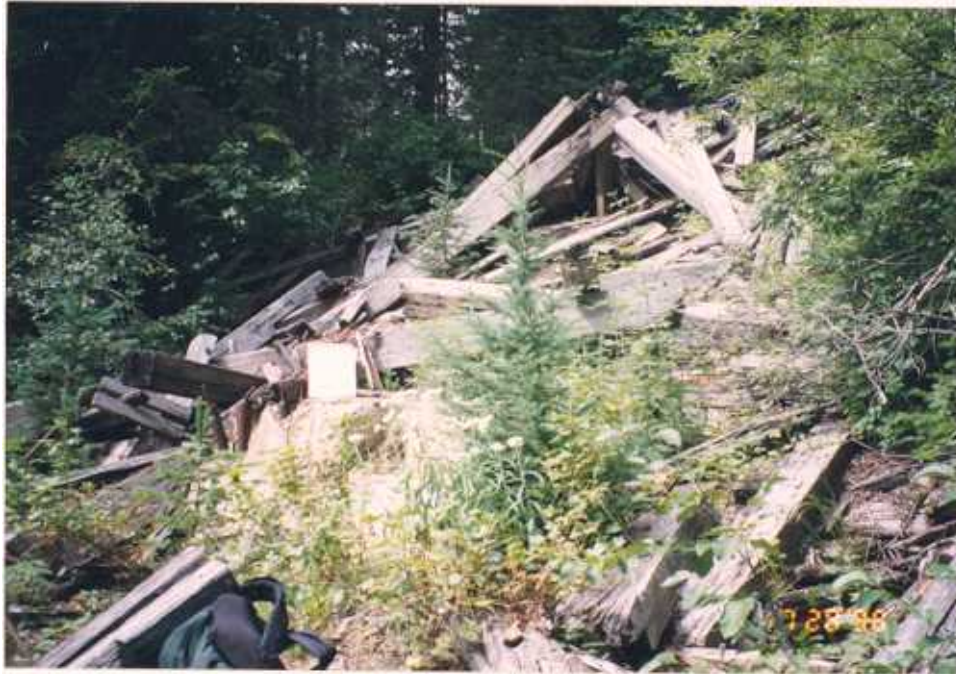
Figure 18a. Collapsed mill ruins lay beside Bramlet Creek; no trace of its tailings could be found.

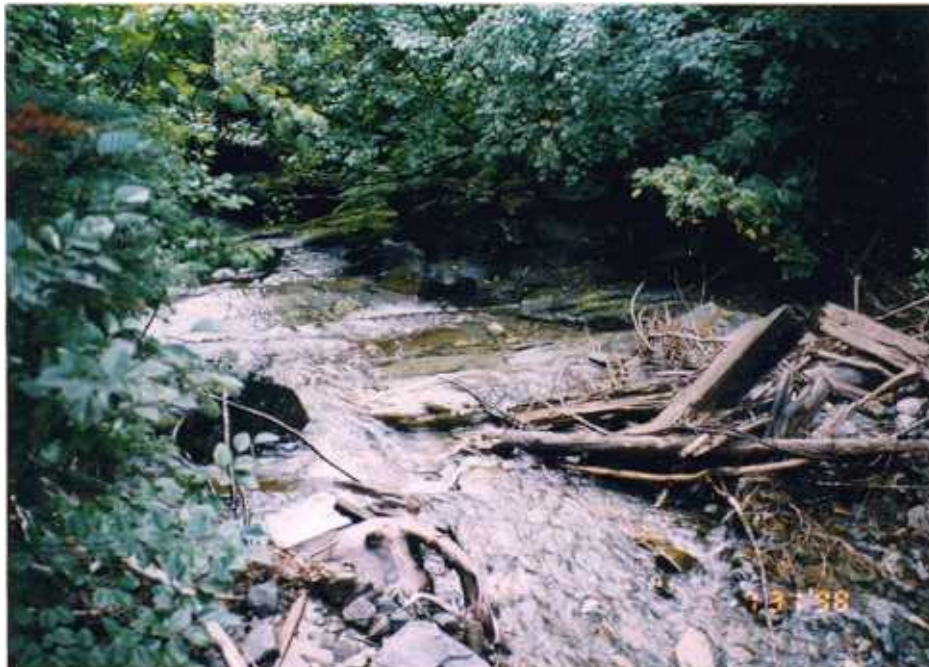
Figure 18b. Bramlet Creek ran clear and cold downstream from the Bramlet Creek mill.

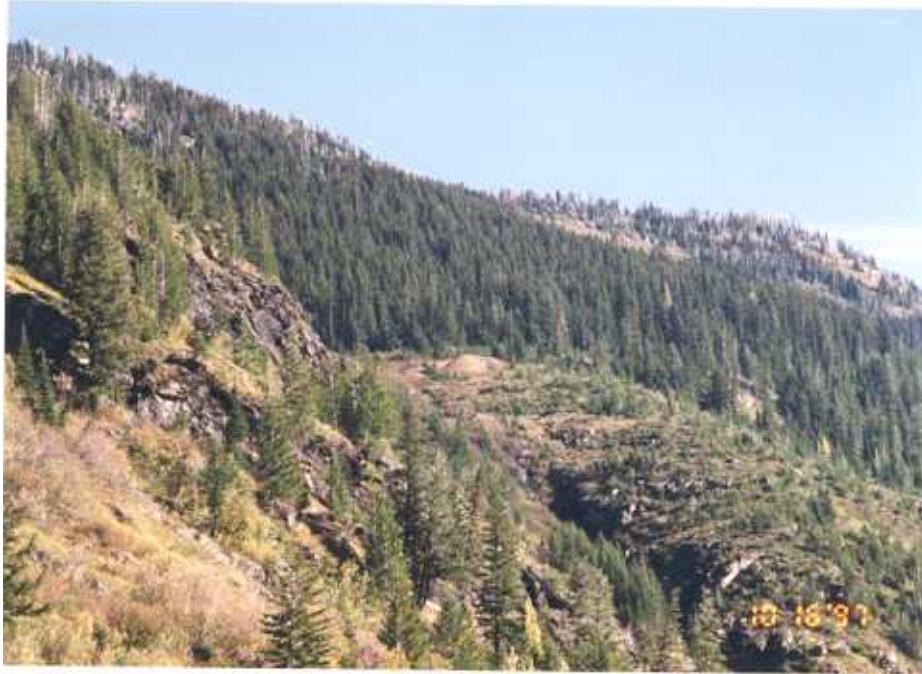
Figure 19a. As viewed from the road to the Wayup mine, the Gloria's waste dumps and cabin were visible on the south-facing slope north of West Fisher Creek.

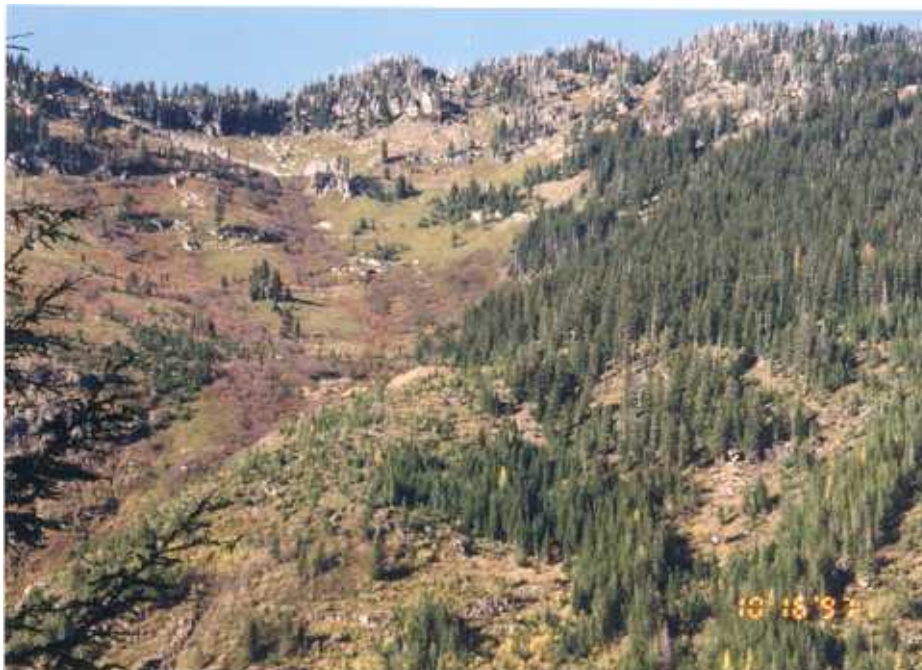
Figure 19b. One waste dump at the Gloria was in contact with the unnamed tributary to West Fisher Creek.

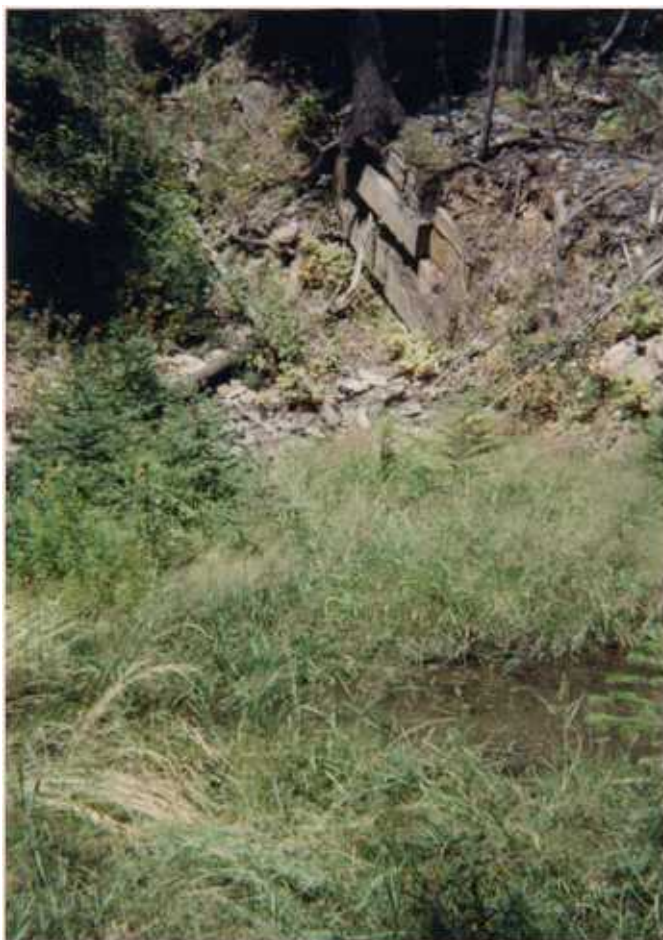
Figure 21a. A seep emerged from the collapsed adit portal at the Copper Reward, flowed approximately 20 feet where it formed a small pool on the waste dump. It then infiltrated the dump.

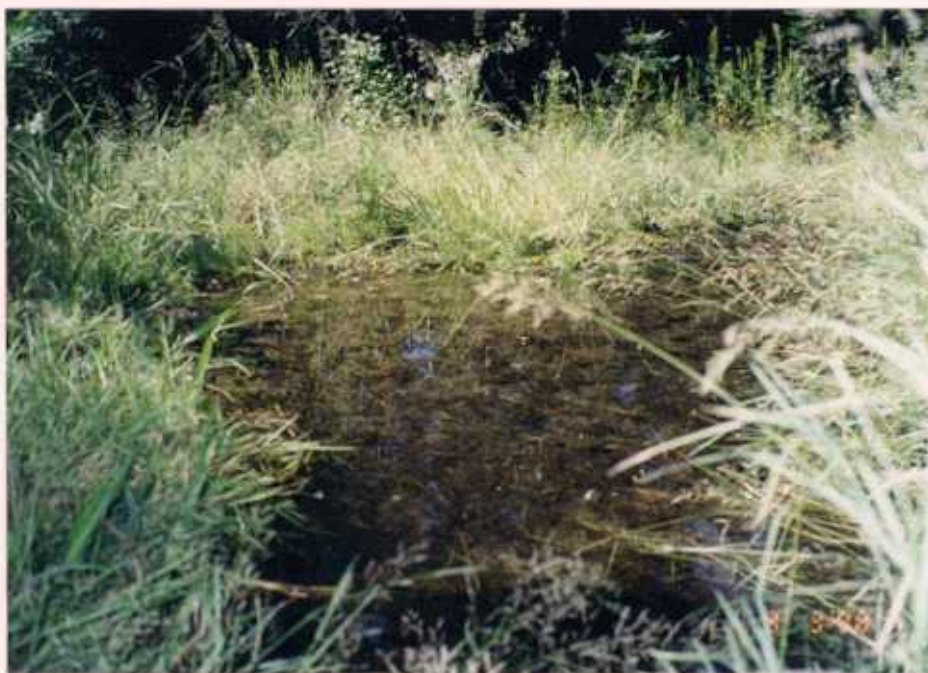
Figure 21b. At the Copper Reward, lush green vegetation grew up to edge of the pool formed by the adit discharge.

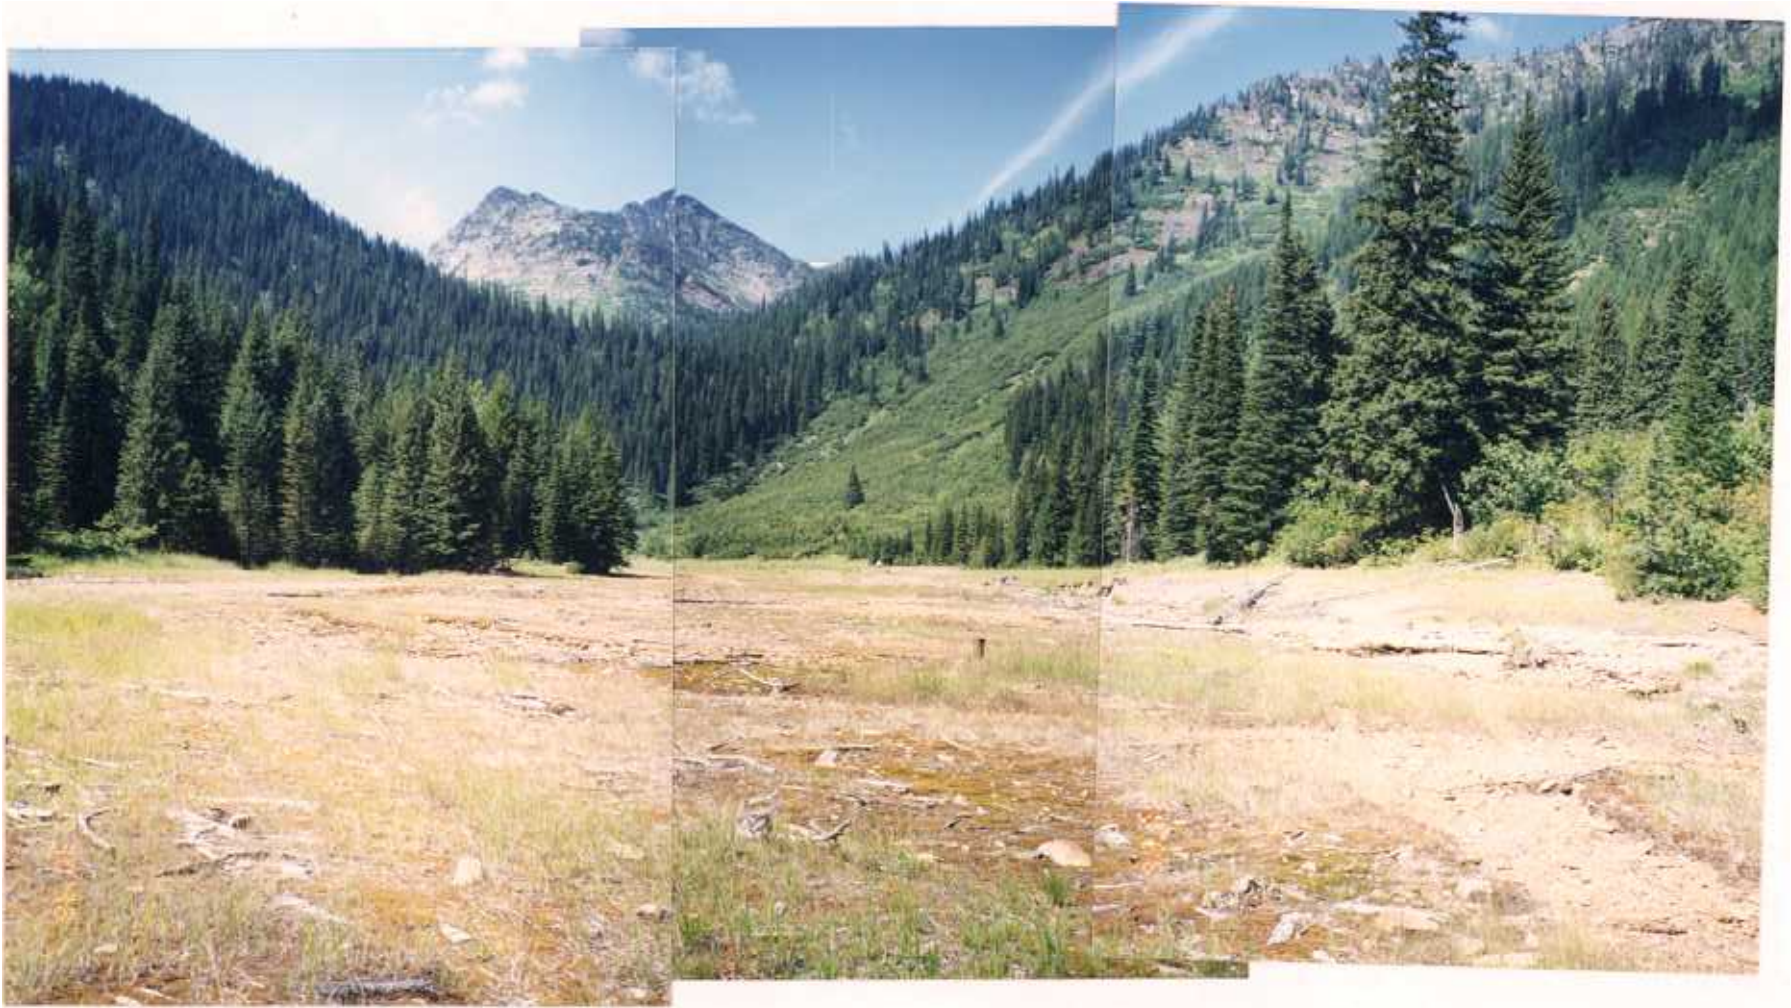
Figure 22a. A panorama looking west shows the flat reclaimed area. The adits at the Snowshoe were behind the trees to the left, and the mill was in the valley bottom. A monitoring well is in the right foreground. Snowshoe Creek flows from the notch in the center of the photo and then to toward the right foreground. There are numerous springs and seeps flowing in the area, possibly associated with the Snowshoe fault.
