Montana Bureau of Mines and Geology
Abandoned-Inactive Mines of the
Kootenai National Forest-Administered Land

Abandoned-Inactive Mines of the
Kootenai National Forest-Administered Land

Open-File Report
MBMG 395

December 1999

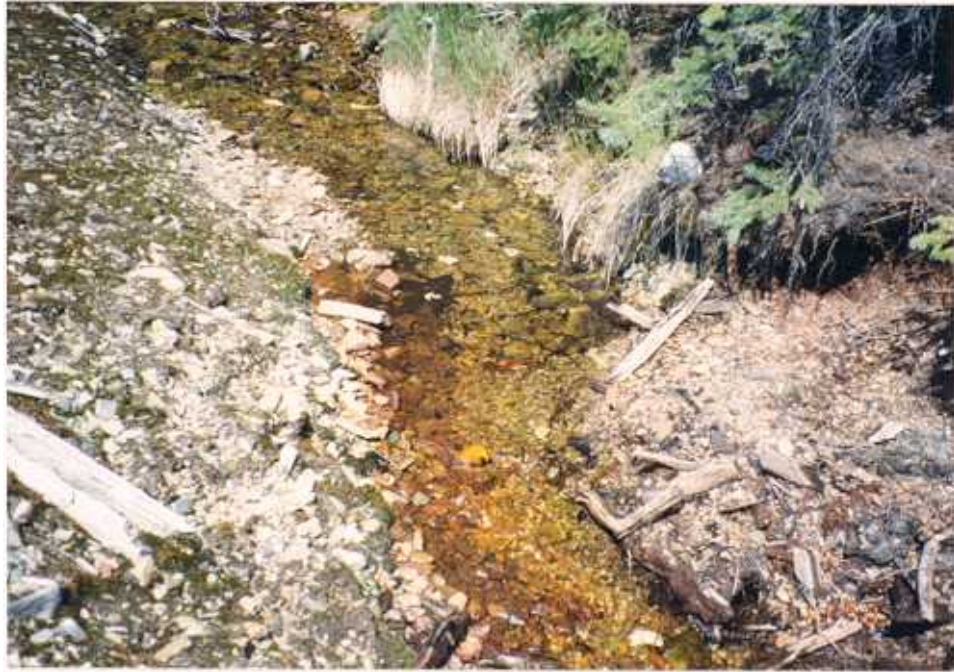
Figure 22b. At the Snowshoe, a seep emerged from the disturbed area on the north side of the flat area and mixed with the water from a natural spring. The iron staining that is evident distinguishes the two sources.

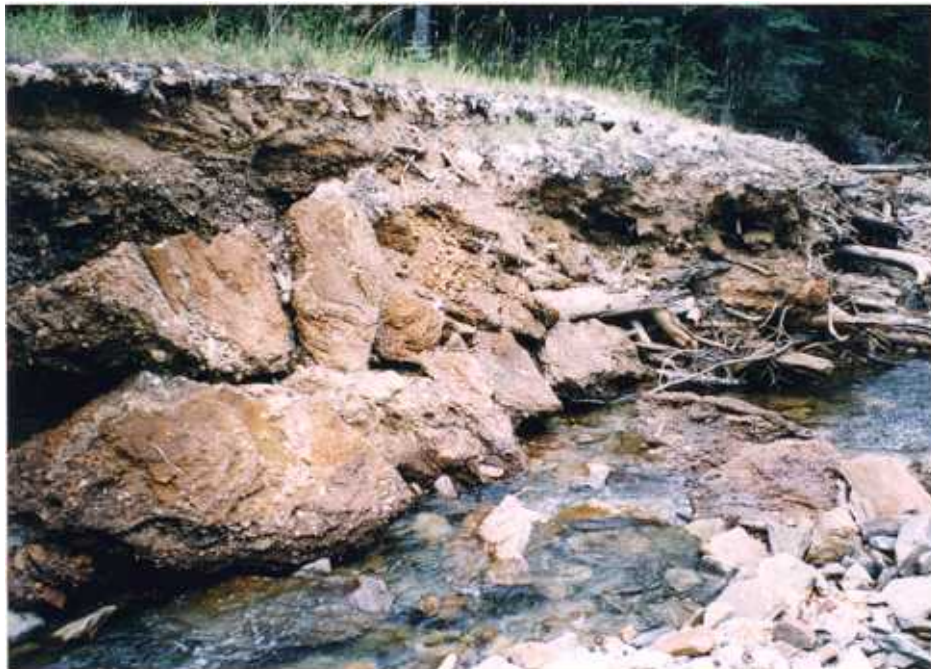
Figure 22c. Recently indurated mine waste downstream of the Snowshoe was actively being undercut by Snowshoe Creek. A white clay capping lies on the surface of the waste and tailings.

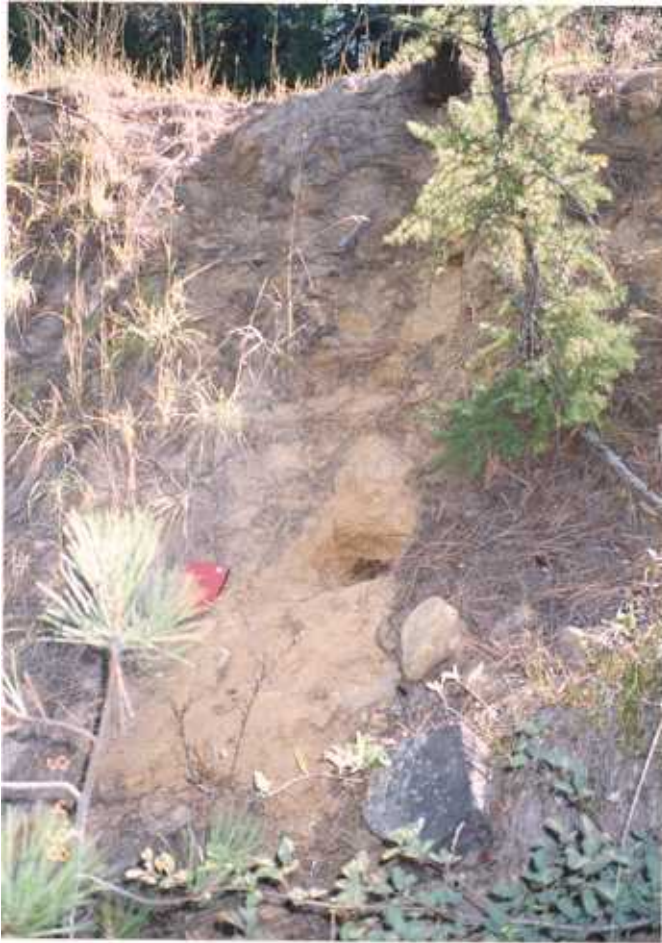
Figure 23a. Tailings sample CCHT10H from the Cherry Creek mill was taken from a thick remnant of the pile.

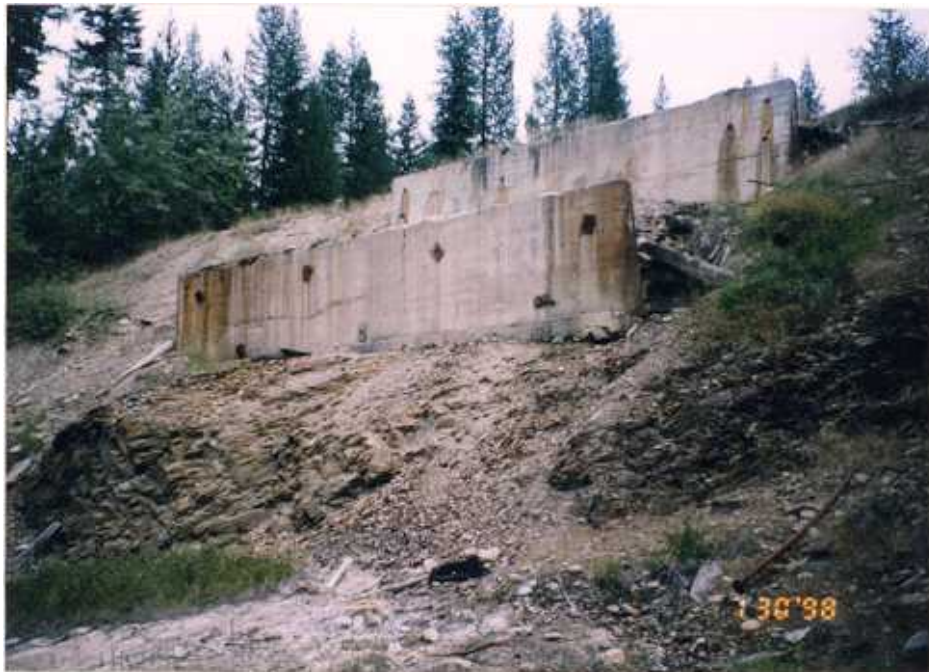
Figure 23b. The foundation of the mill at the Cherry Creek site posed a safety threat because of erosion at the footings.

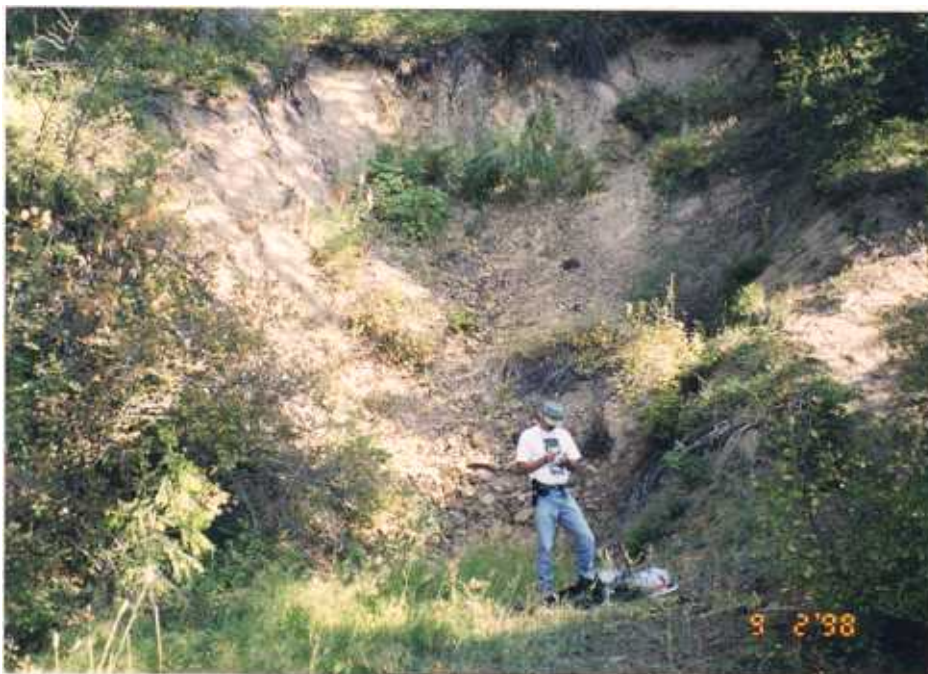
Figure 26a. The Loyal mine's one collapsed adit was located by following the trail to Horse Creek from the Shaughnessy Creek drainage.

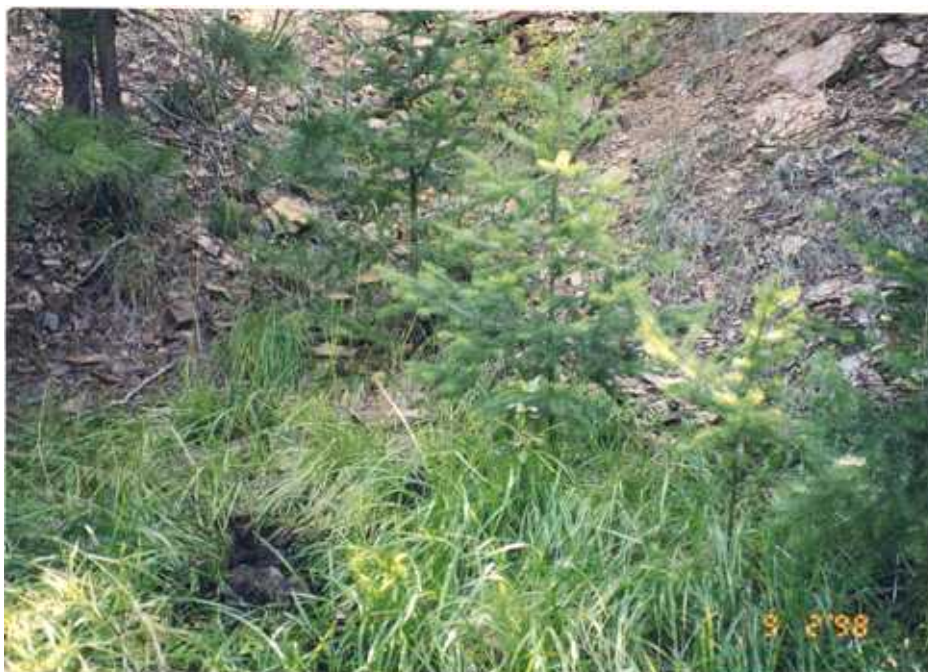
Figure 26b. A small pool of water formed at the caved portal of the Shaughnessy Creek adit. The water was sampled to test the effect of the mine.

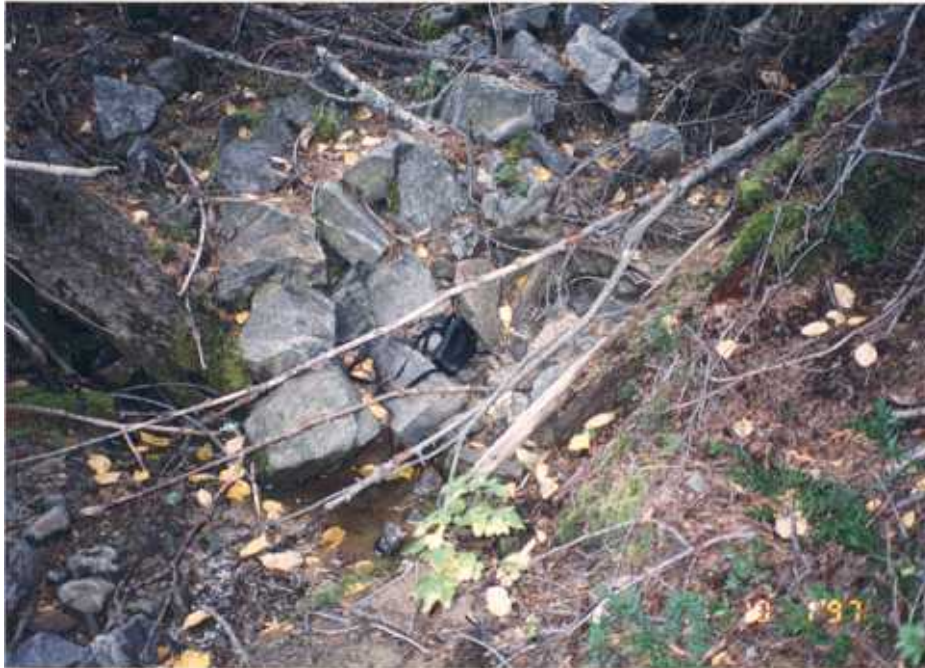
Figure 27a. The intermittent drainage that is a tributary to Carr Draw eroded the Grouse Mountain mine's waste dump.

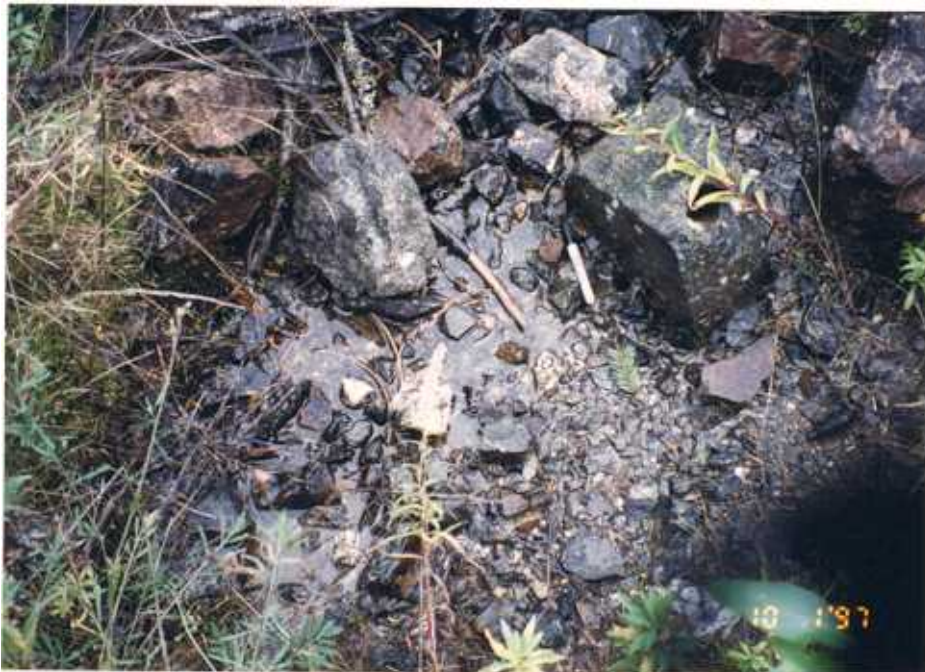
Figure 27b. A 0.5-gpm seep was found on KNF-administered land on top of the waste dump at the Iron Mask.

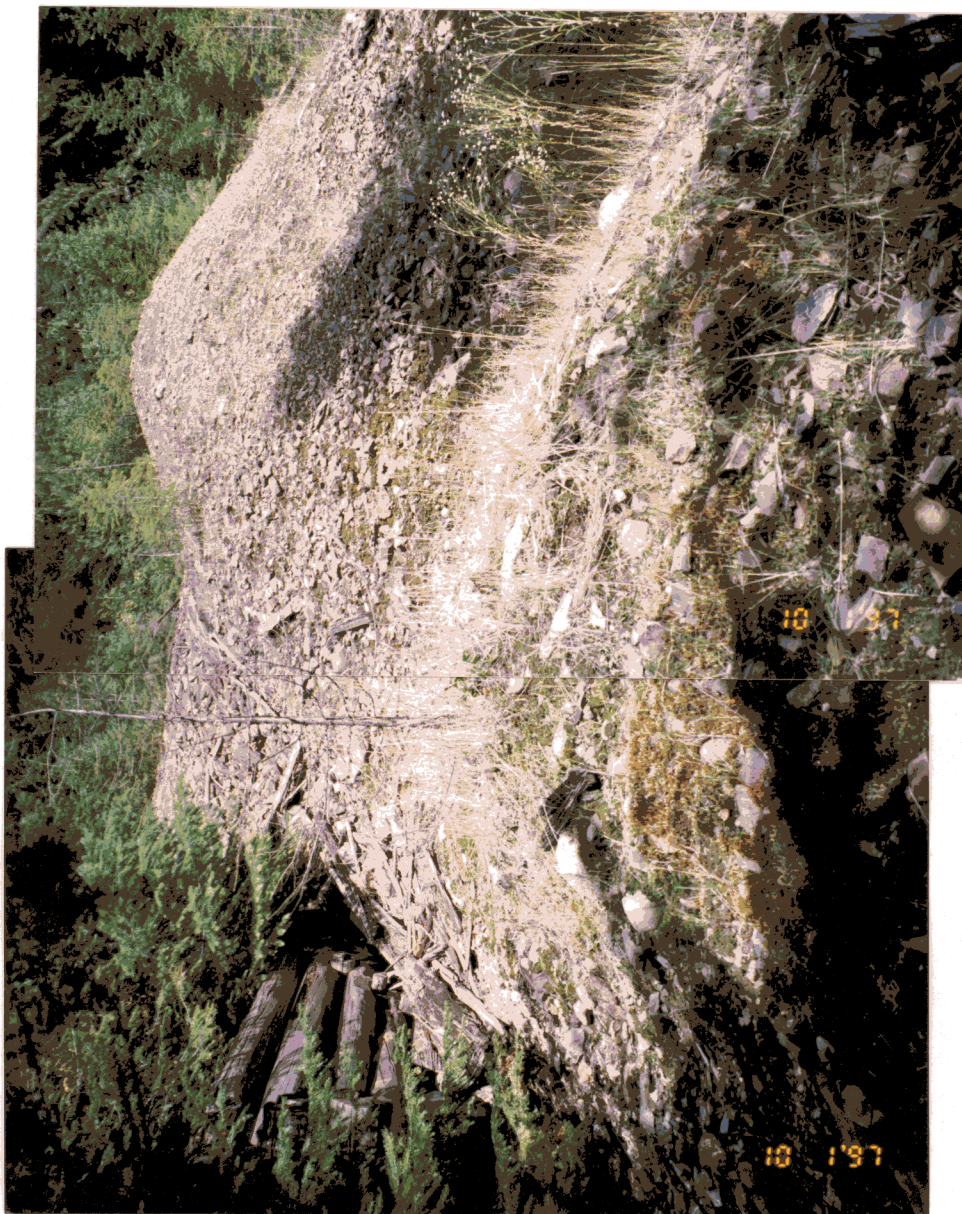
Figure 28a. Photos of the Grouse Mountain mine show the waste that was dumped in the drainage.

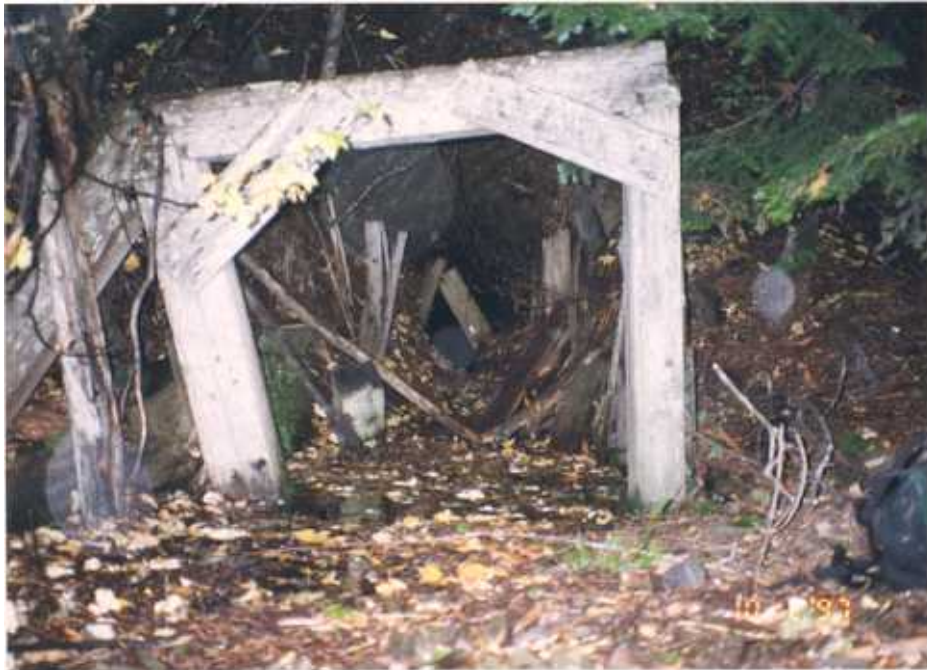
Figure 29a. The open adit at the Giant Sunrise held standing water but none was flowing at the surface to the active drainage.

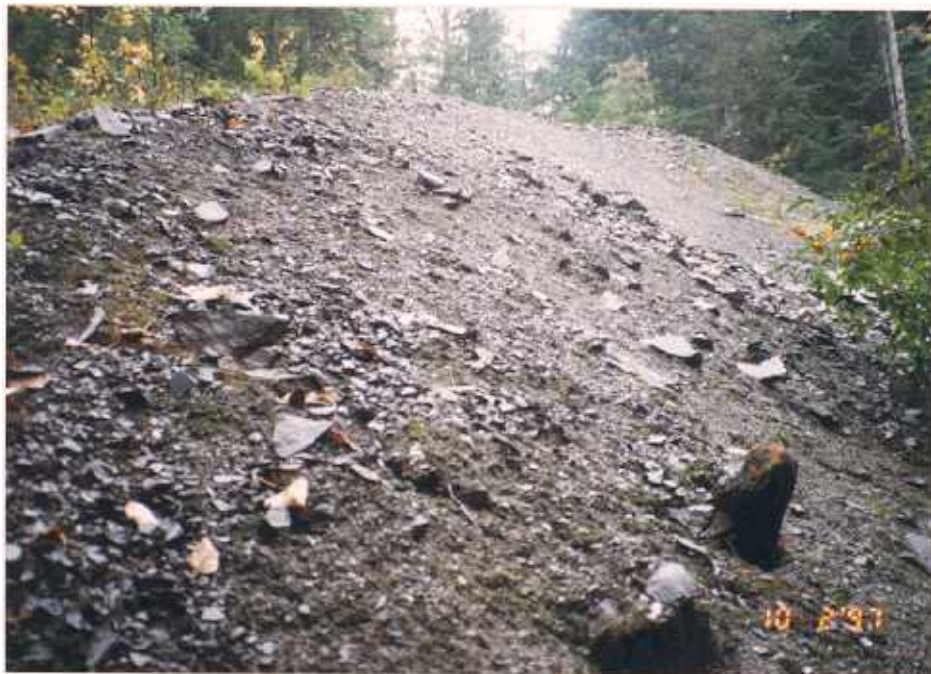
Figure 29b. The waste dump had been eroded by runoff, and a small seep flowed from the base of the dump.

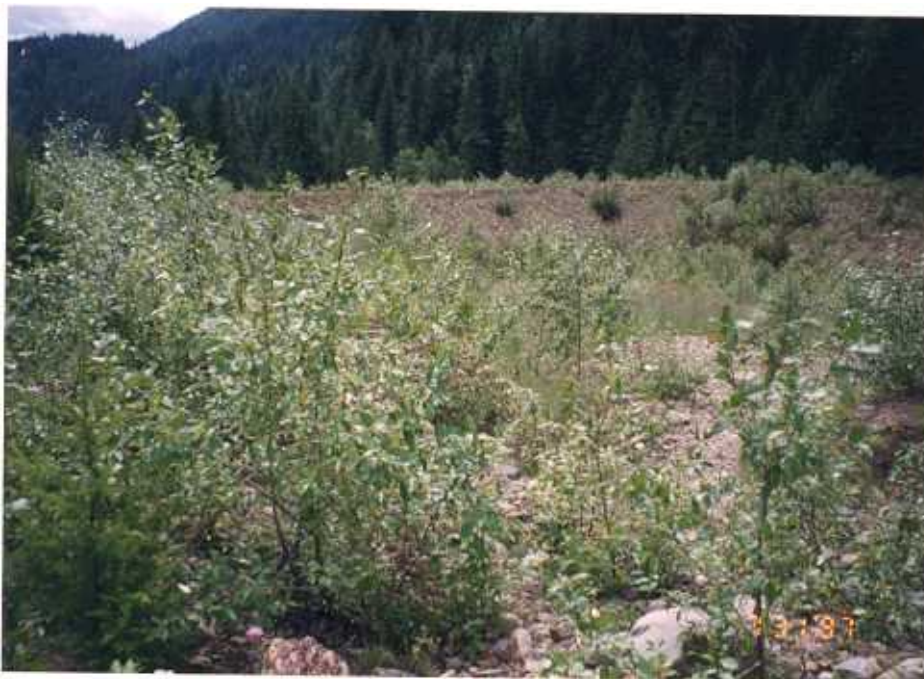
Figure 30a. As seen from KNF-administered land, the tailings were fairly well vegetated and the tailings were dry.

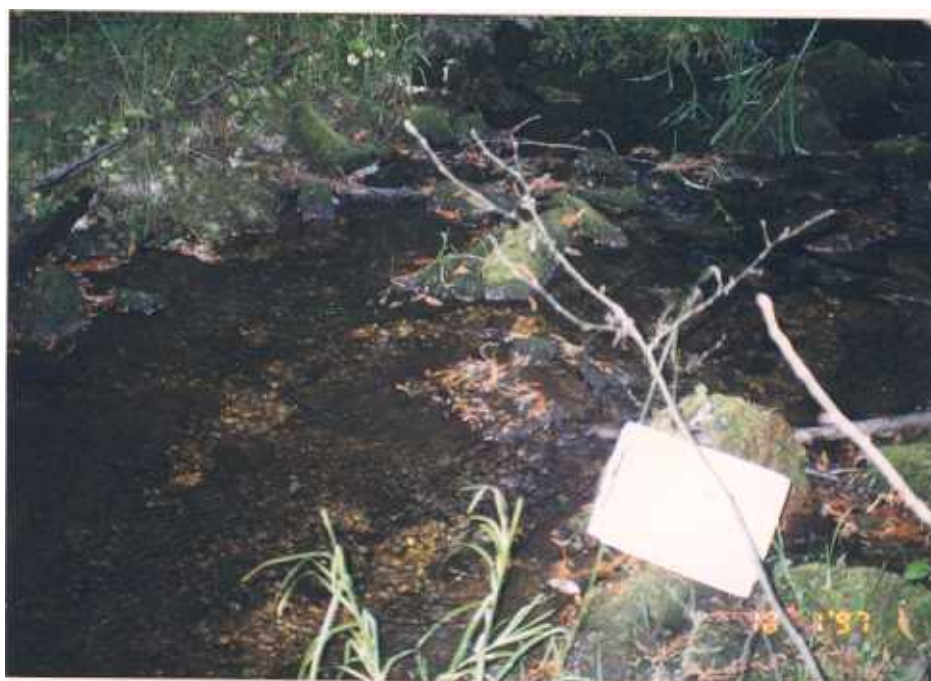
Figure 30b. The water at the sample site on Copper Creek was fairly stagnant, but the vegetation appeared very healthy.

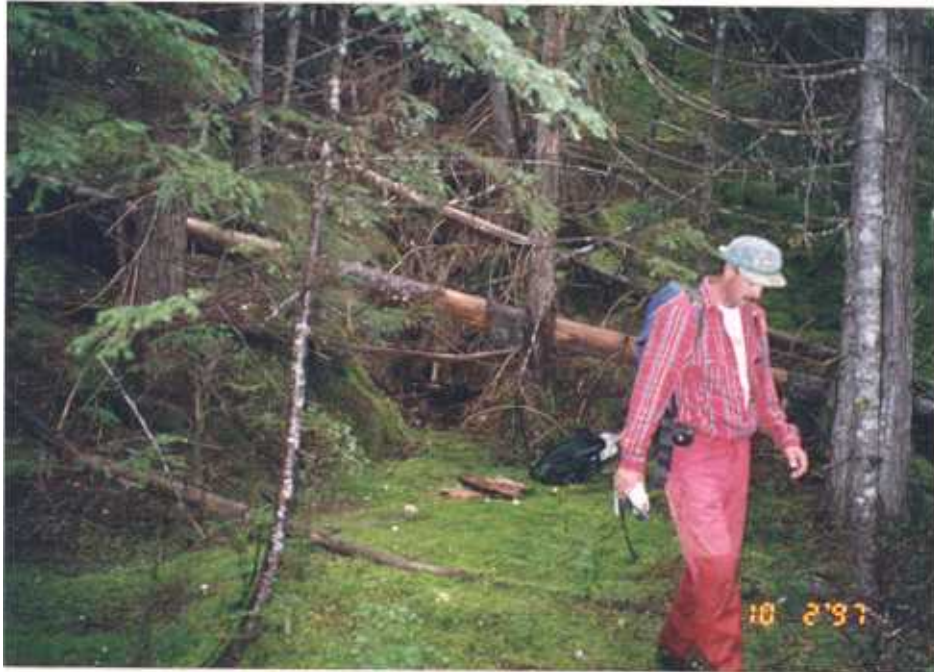
Figure 31a. The caved Goat Creek adit is barely discernible to the left of the green backpack. There was no evidence of any adit discharge.

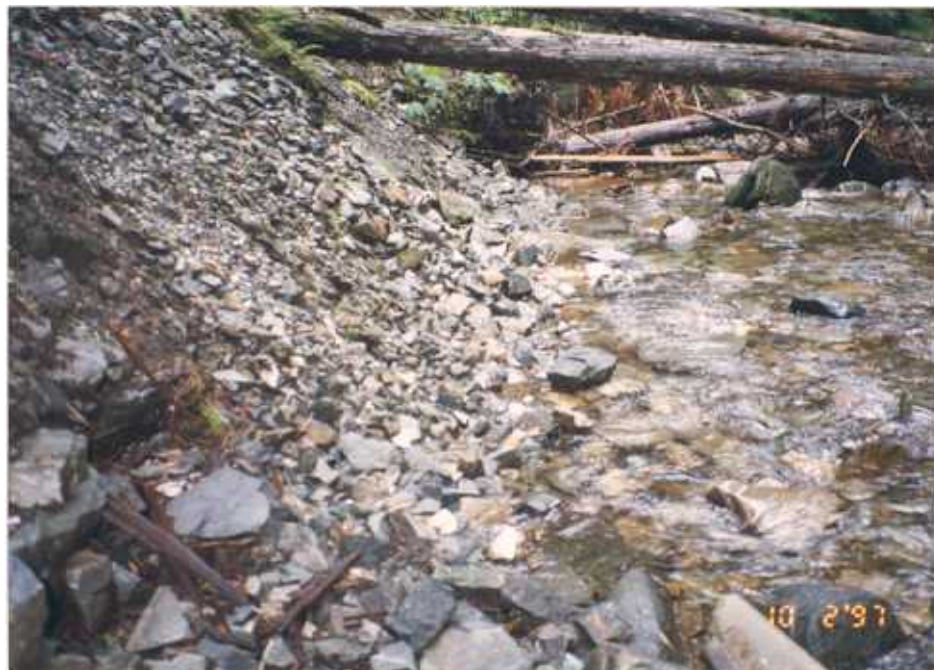
Figure 31b. The sparsely vegetated waste dump was in direct contact with Goat Creek. The large size of the fragments that compose the dump inhibits erosion of the waste.

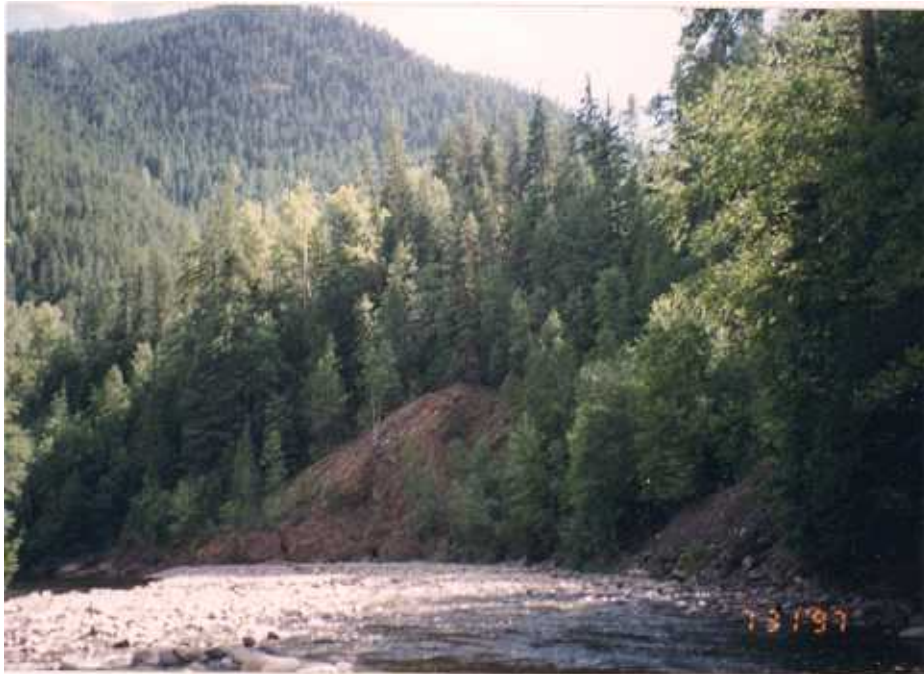
Figure 32a. Looking downstream on Callahan Creek, the waste dumps are largely eroded away by spring floods.

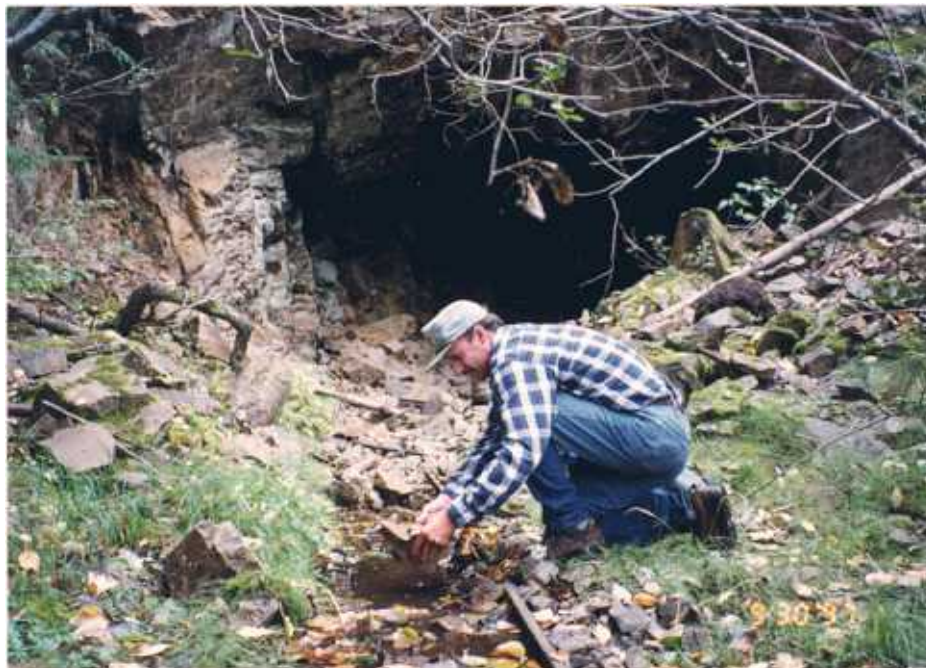
Figure 32b. The adit discharge from the open adit at the Snowstorm was sampled in September 30, 1997. The total flow was estimated at five gpm.
