Here today, gone tomorrow?

by
Mary Pickett
of the Billings Gazette Staff

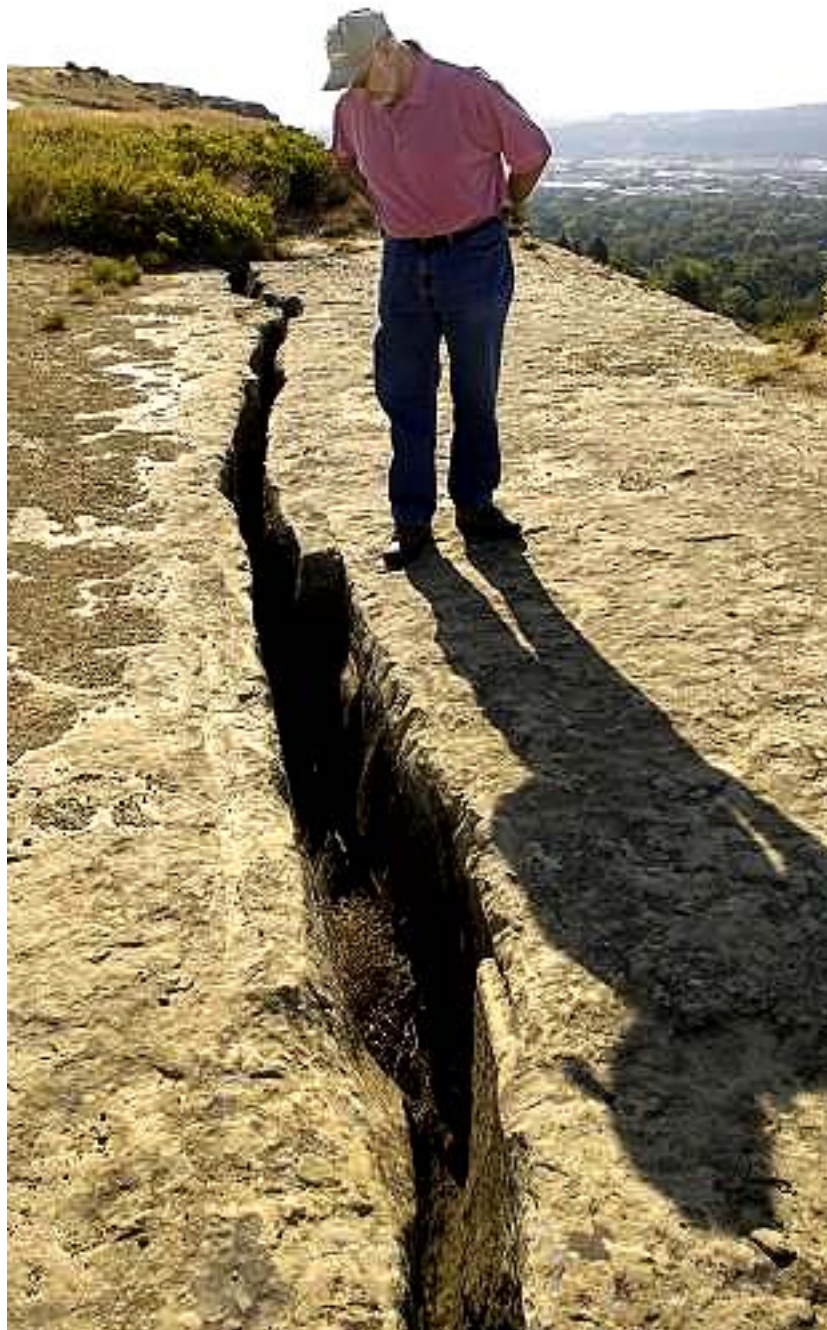
Geologist David Lopez says that it's "spooky" how deep one large crack in the Rimrocks is.

The large chunk of Rims, about 30-by-10-feet on the top surface, is moving away from the main cliff.

The rock already has slumped a couple of inches lower than the main face.

The eastern edge of the rock has a sharp edge with no lichen growing along the interior walls and dirt remains piled up on one of the corners. They are all signs that movement has happened recently.
